CITY OF CITRUS HEIGHTS

Neighborhoods 6 & 7 Storm Drainage Master Plan Study

March 2012

396-00-10-01

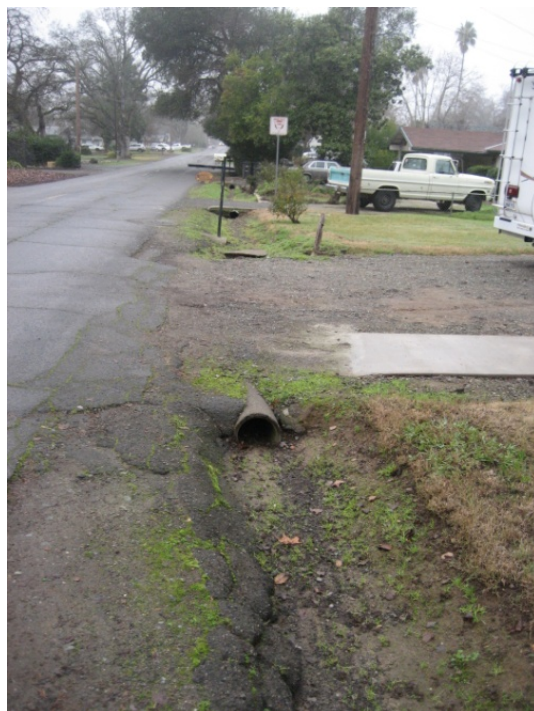
Photo 1. Roadside Ditches and Driveway Culverts – Looking West at Watson Way from Patton Avenue

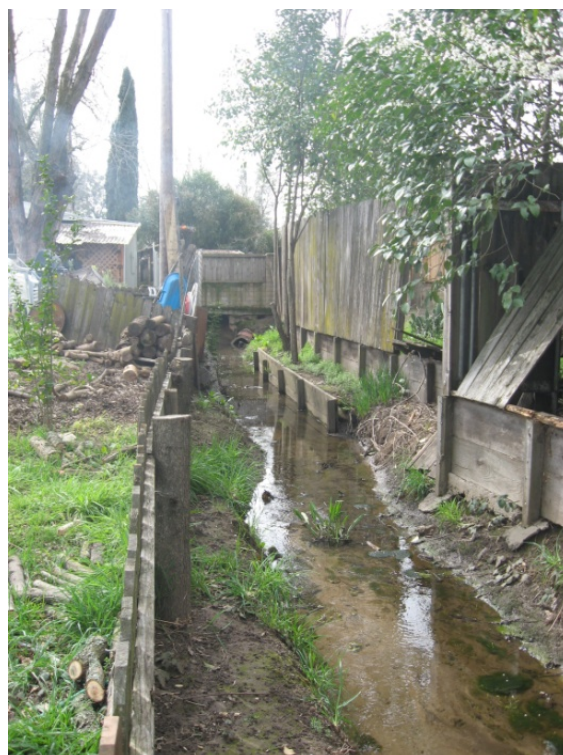
Photo 2. Drainage Channel in Private Backyard – Property on Jessie Way

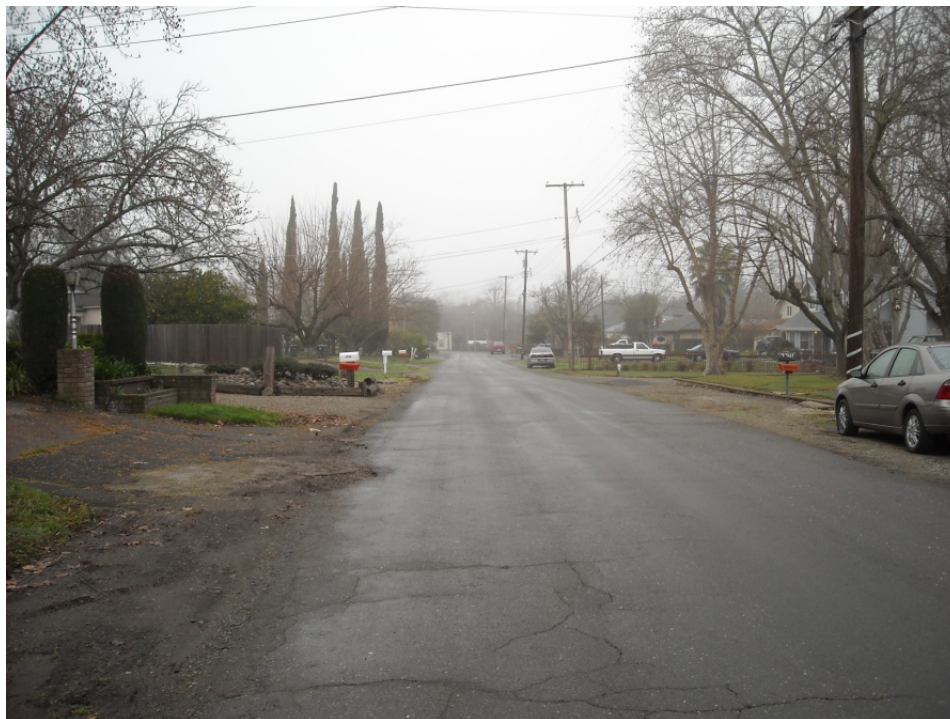
Photo 3. No Roadside Ditches or Driveway Culverts – Looking West Down Loleta Way

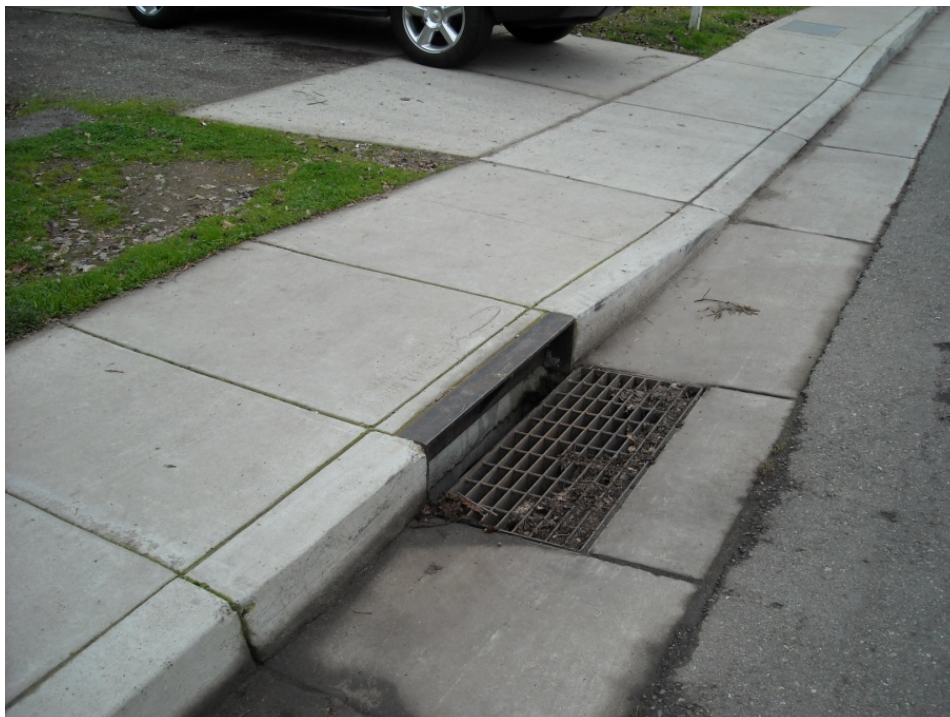
Photo 4. Curb, Gutter and Inlet – Mariposa Avenue at Cina Way

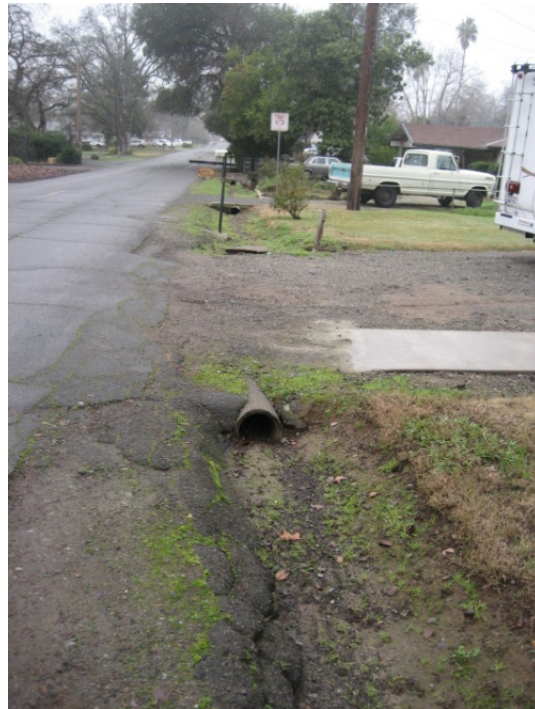
**Photo 3-1. Roadside Ditches and Driveway Culverts – Looking West
at Watson Way from Patton Avenue**

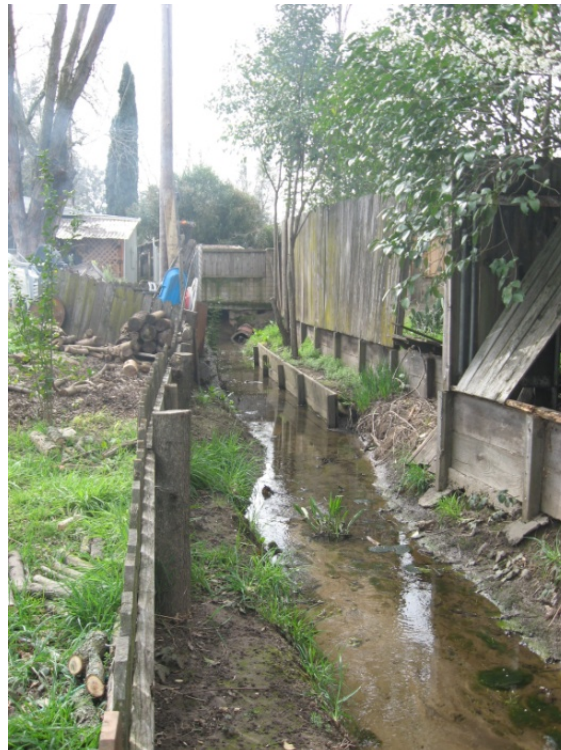
Photo 3-2. Drainage Channel in Private Backyard – Property on Jessie Way

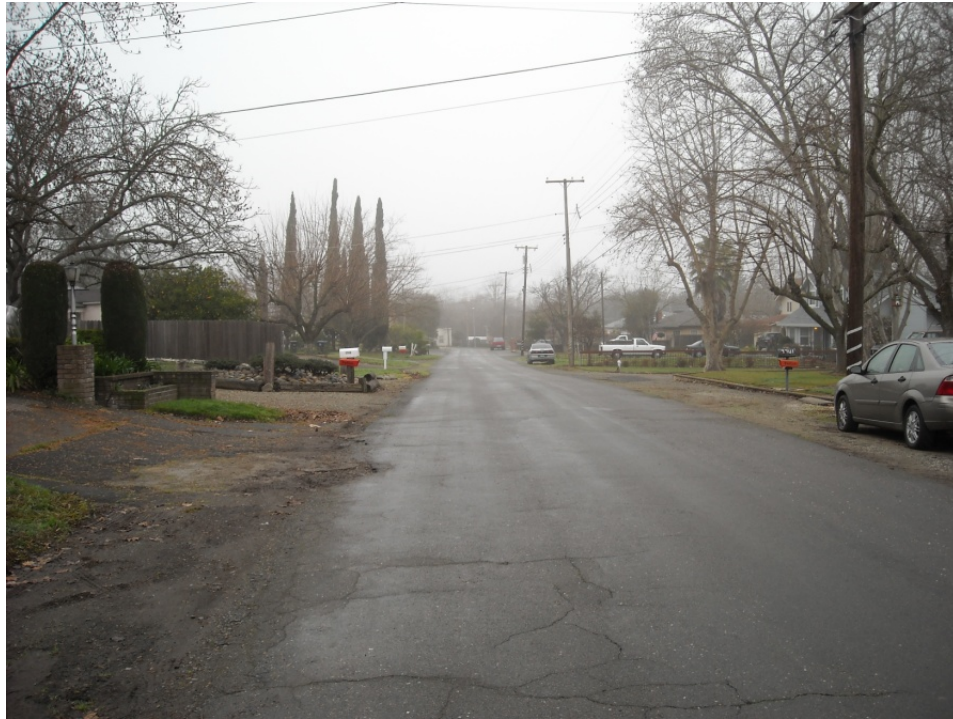
Photo 3-3. No Roadside Ditches or Driveway Culverts – Looking West Down Loleta Way

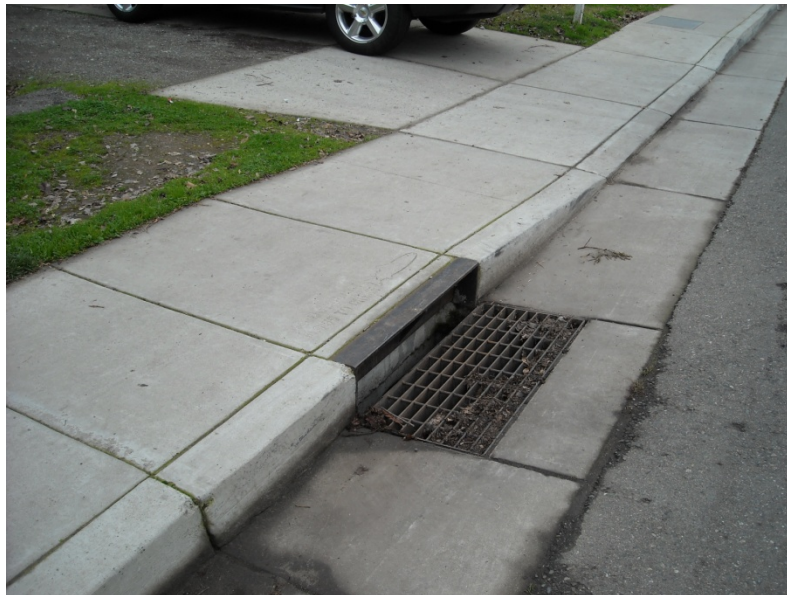
Photo 3-4. Curb, Gutter and Inlet – Mariposa Avenue at Cina Way

- Mariposa Avenue at Cina Way – Manholes were observed at this location and their locations were recorded with a GPS unit. Refer to Sheet C3 of Drainage System Inventory Workmaps.
