City of Citrus Heights Neighborhoods 8, 9, and 10

Storm Drainage Master Plan Study

February 2016

396-00-12-02

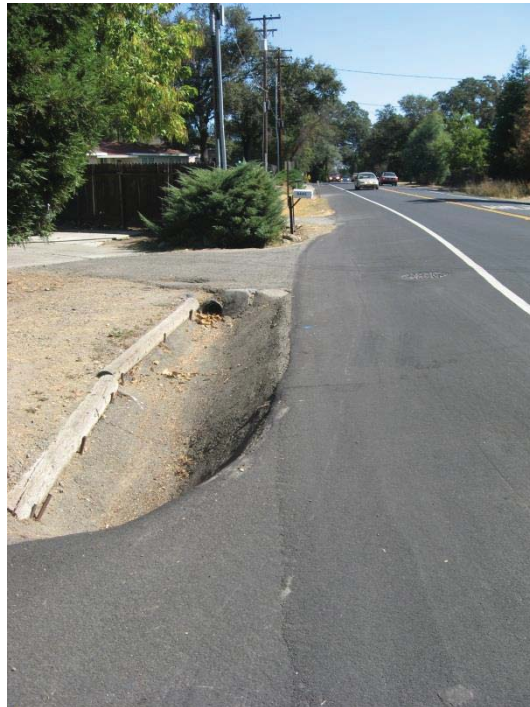
Photo 3-1. Roadside Ditches and Driveway Culverts – Looking Northeast on Old Auburn Road toward Oakwood Hills Circle

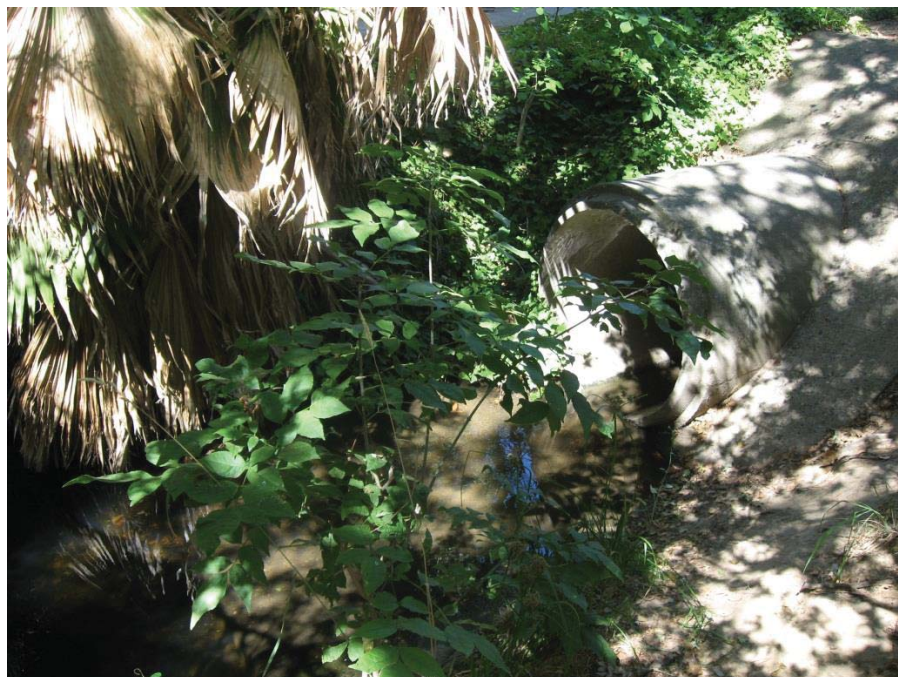
Photo 3-2. Drainage Channel Outlet to Arcade Creek – Near Sweet Gum Court

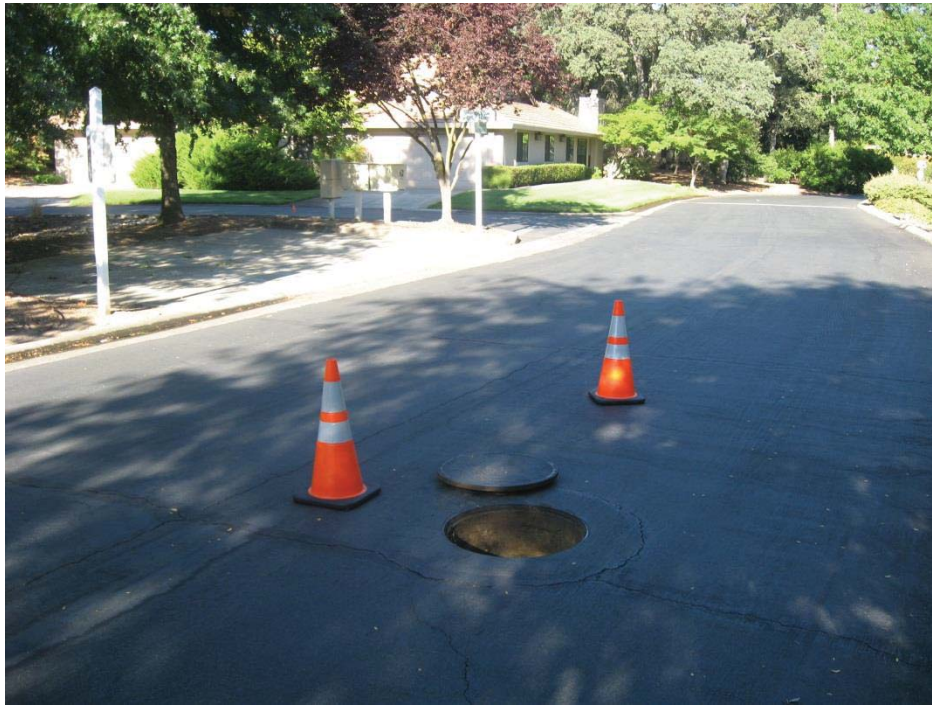
Photo 3-3. No Roadside Ditches or Driveway Culverts – Heritage Meadow Lane near Black Tree Lane

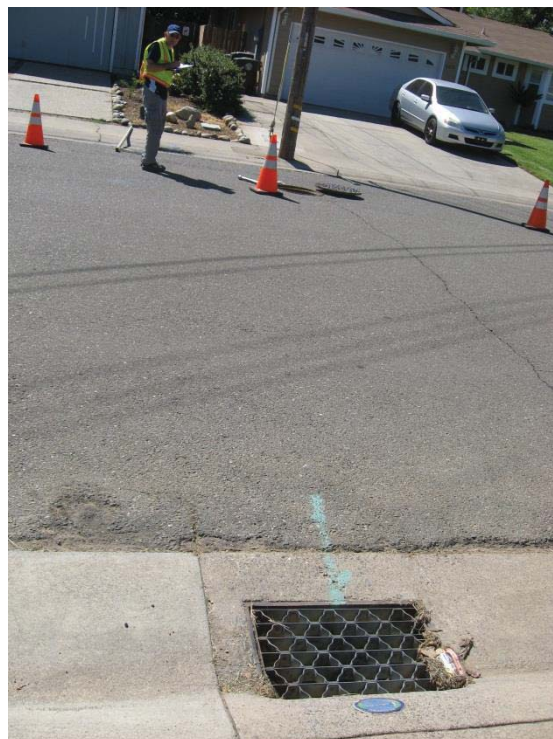
Photo 3-4. Curb, Gutter and Inlet – Rinconada Way

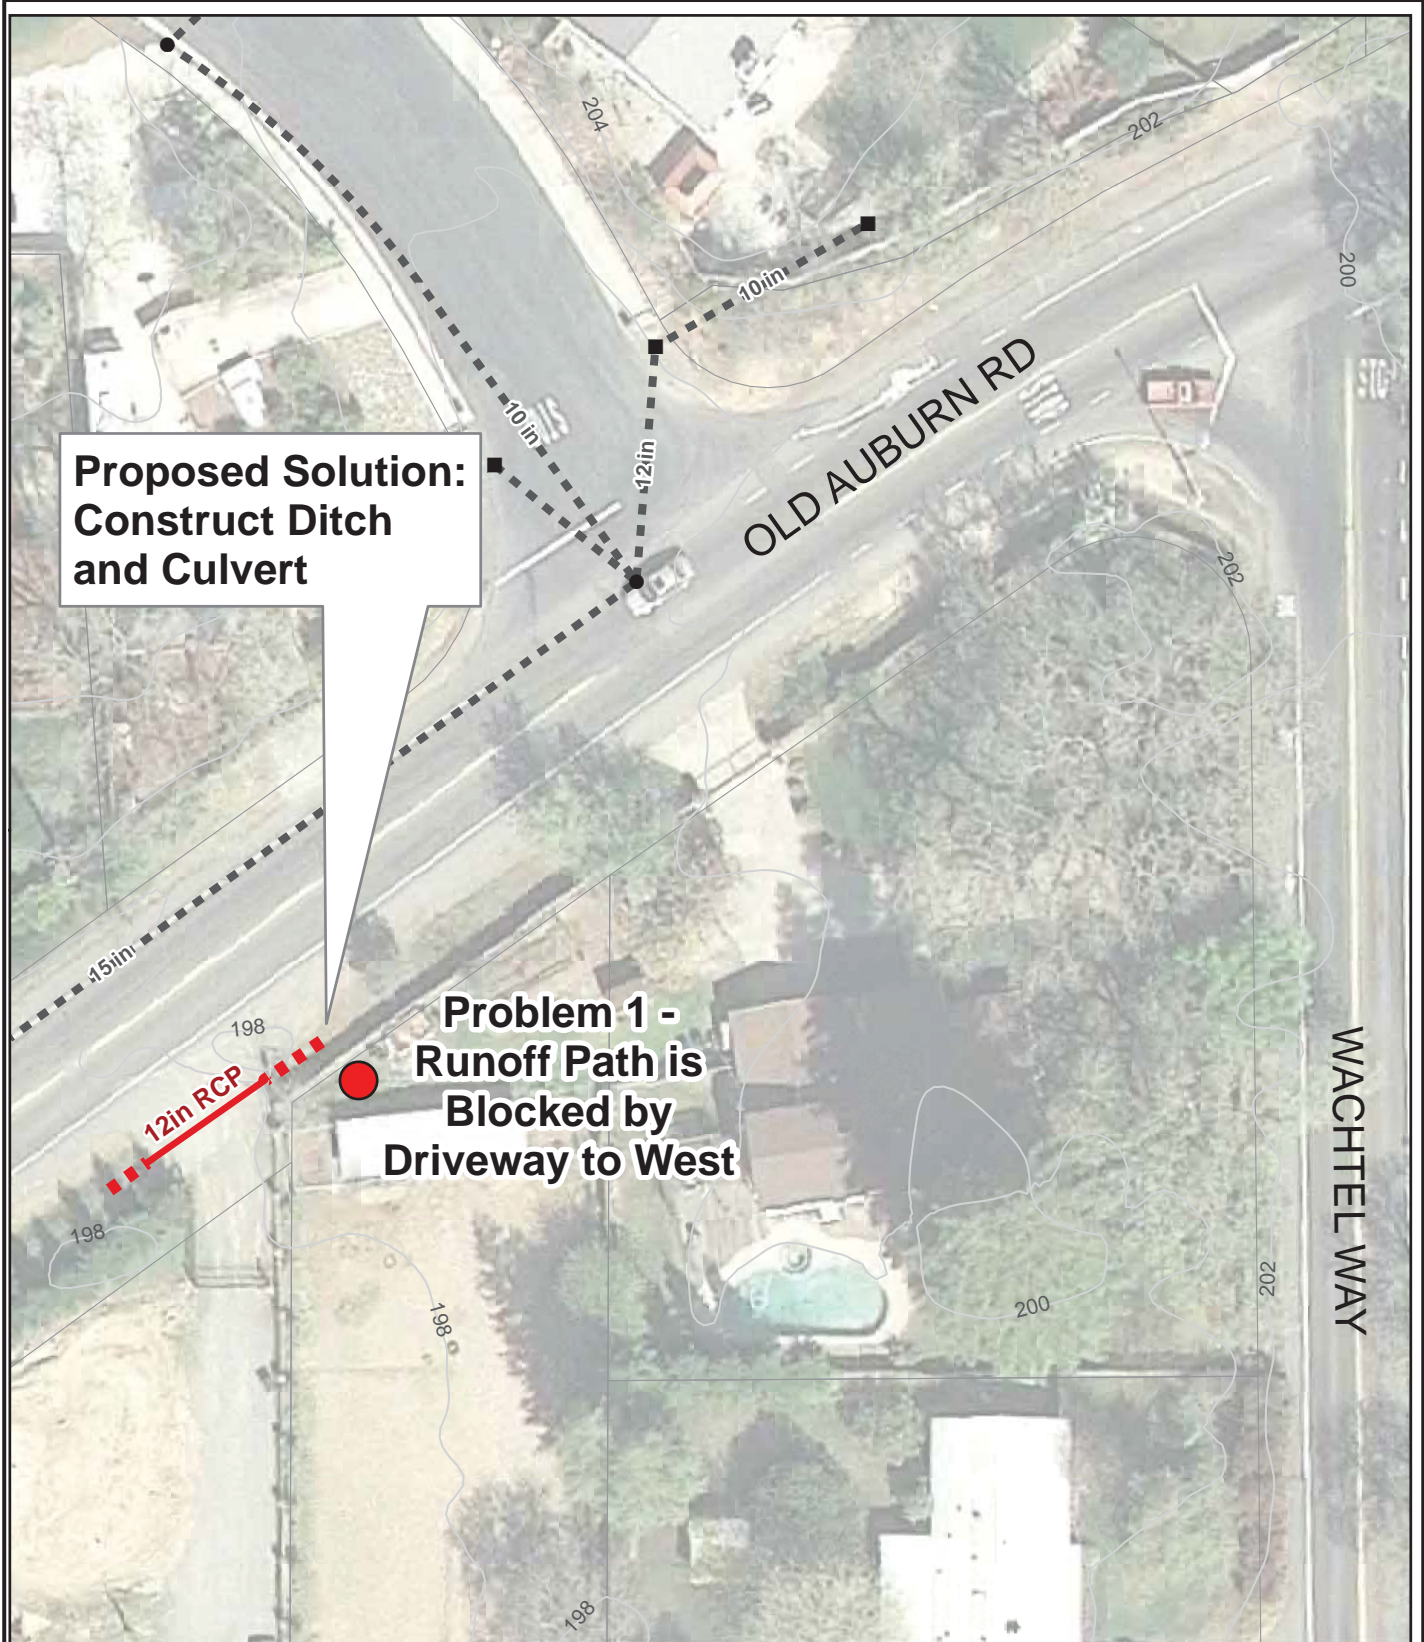
**Problem Location 1
and Proposed Solution**

**Problem 1 -
Runoff Path is
Blocked by
Driveway to West**

**Proposed Solution:
Construct Ditch
and Culvert**

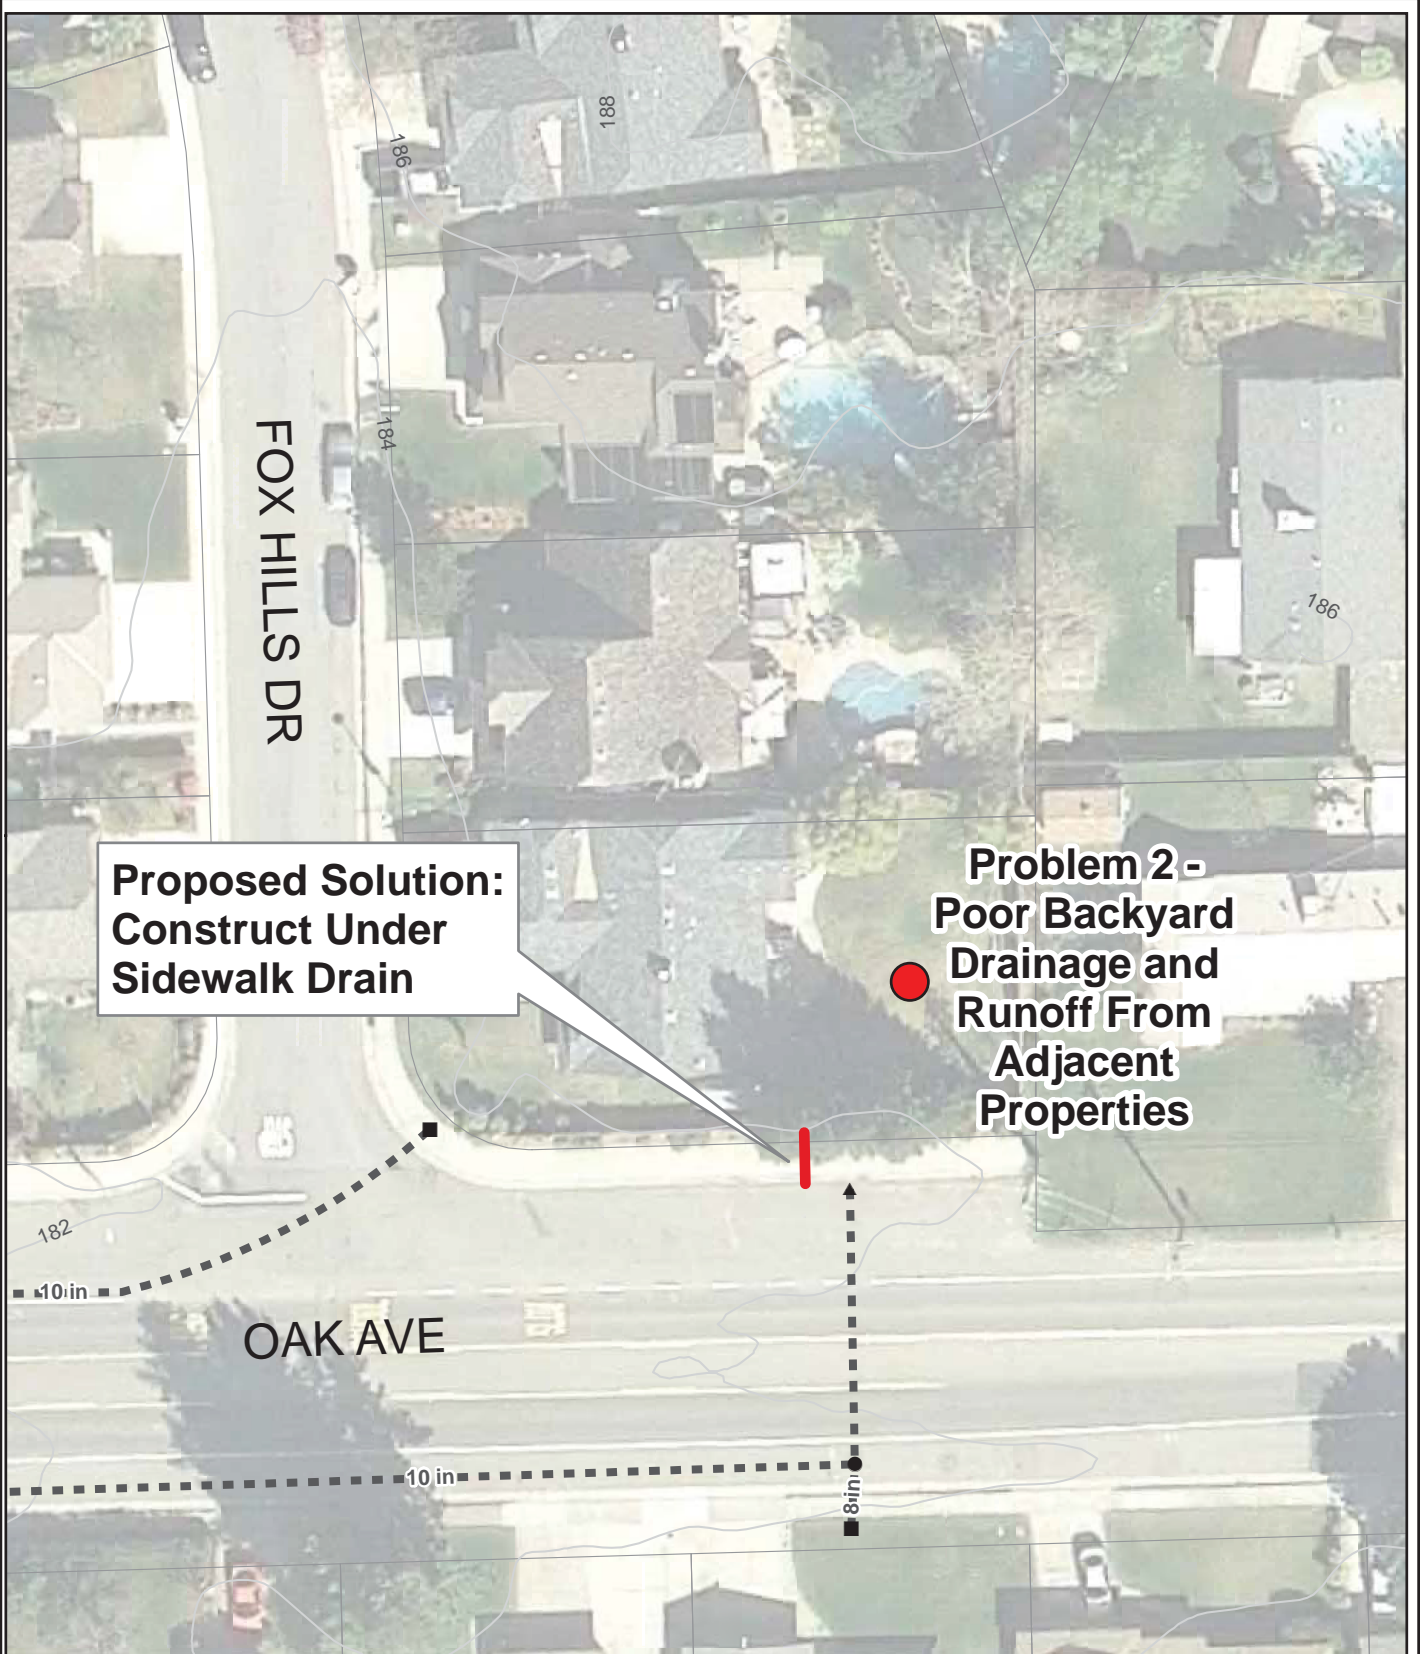
**Problem 2 -
Poor Backyard
Drainage and
Runoff From
Adjacent
Properties**

**Proposed Solution:
Construct Under
Sidewalk Drain**

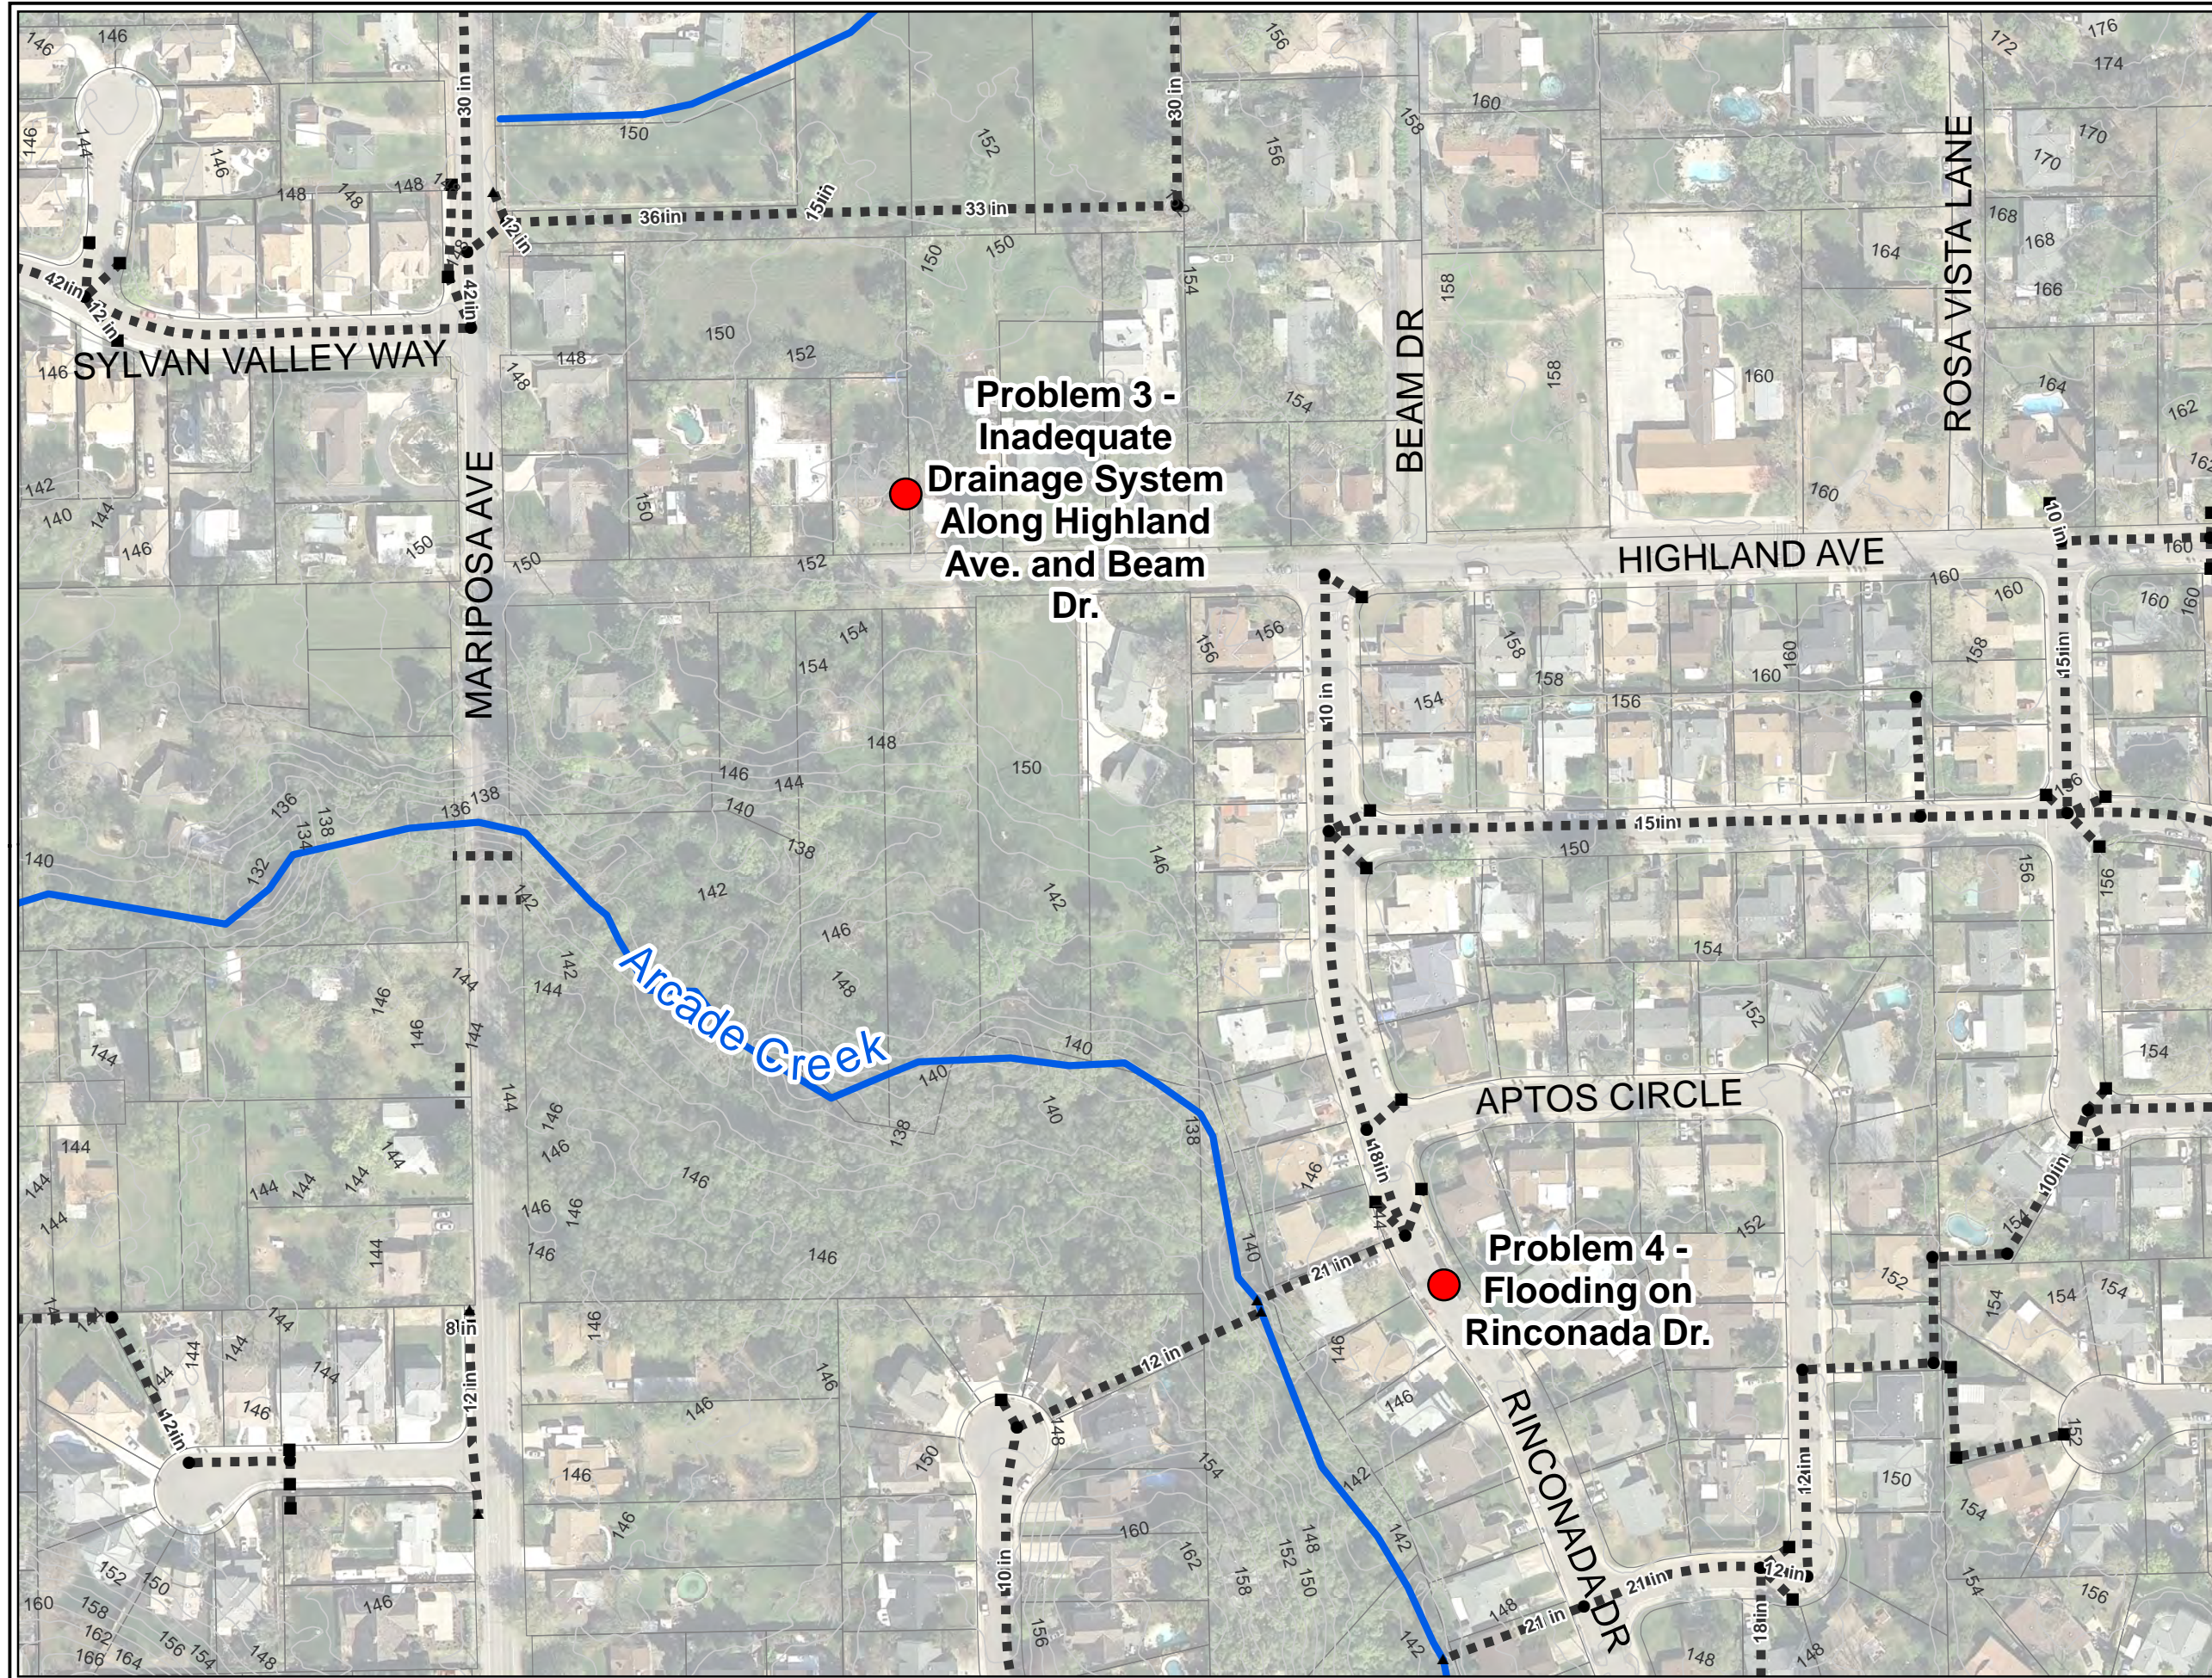
Figure 7-4
City of Citrus Heights
Neighborhoods 8, 9, and 10
Drainage Master Plan Study

Problem 3 -
Inadequate
Drainage System
Along Highland
Ave. and Beam
Dr.

Problem 4 -
Flooding on
Rinconada Dr.

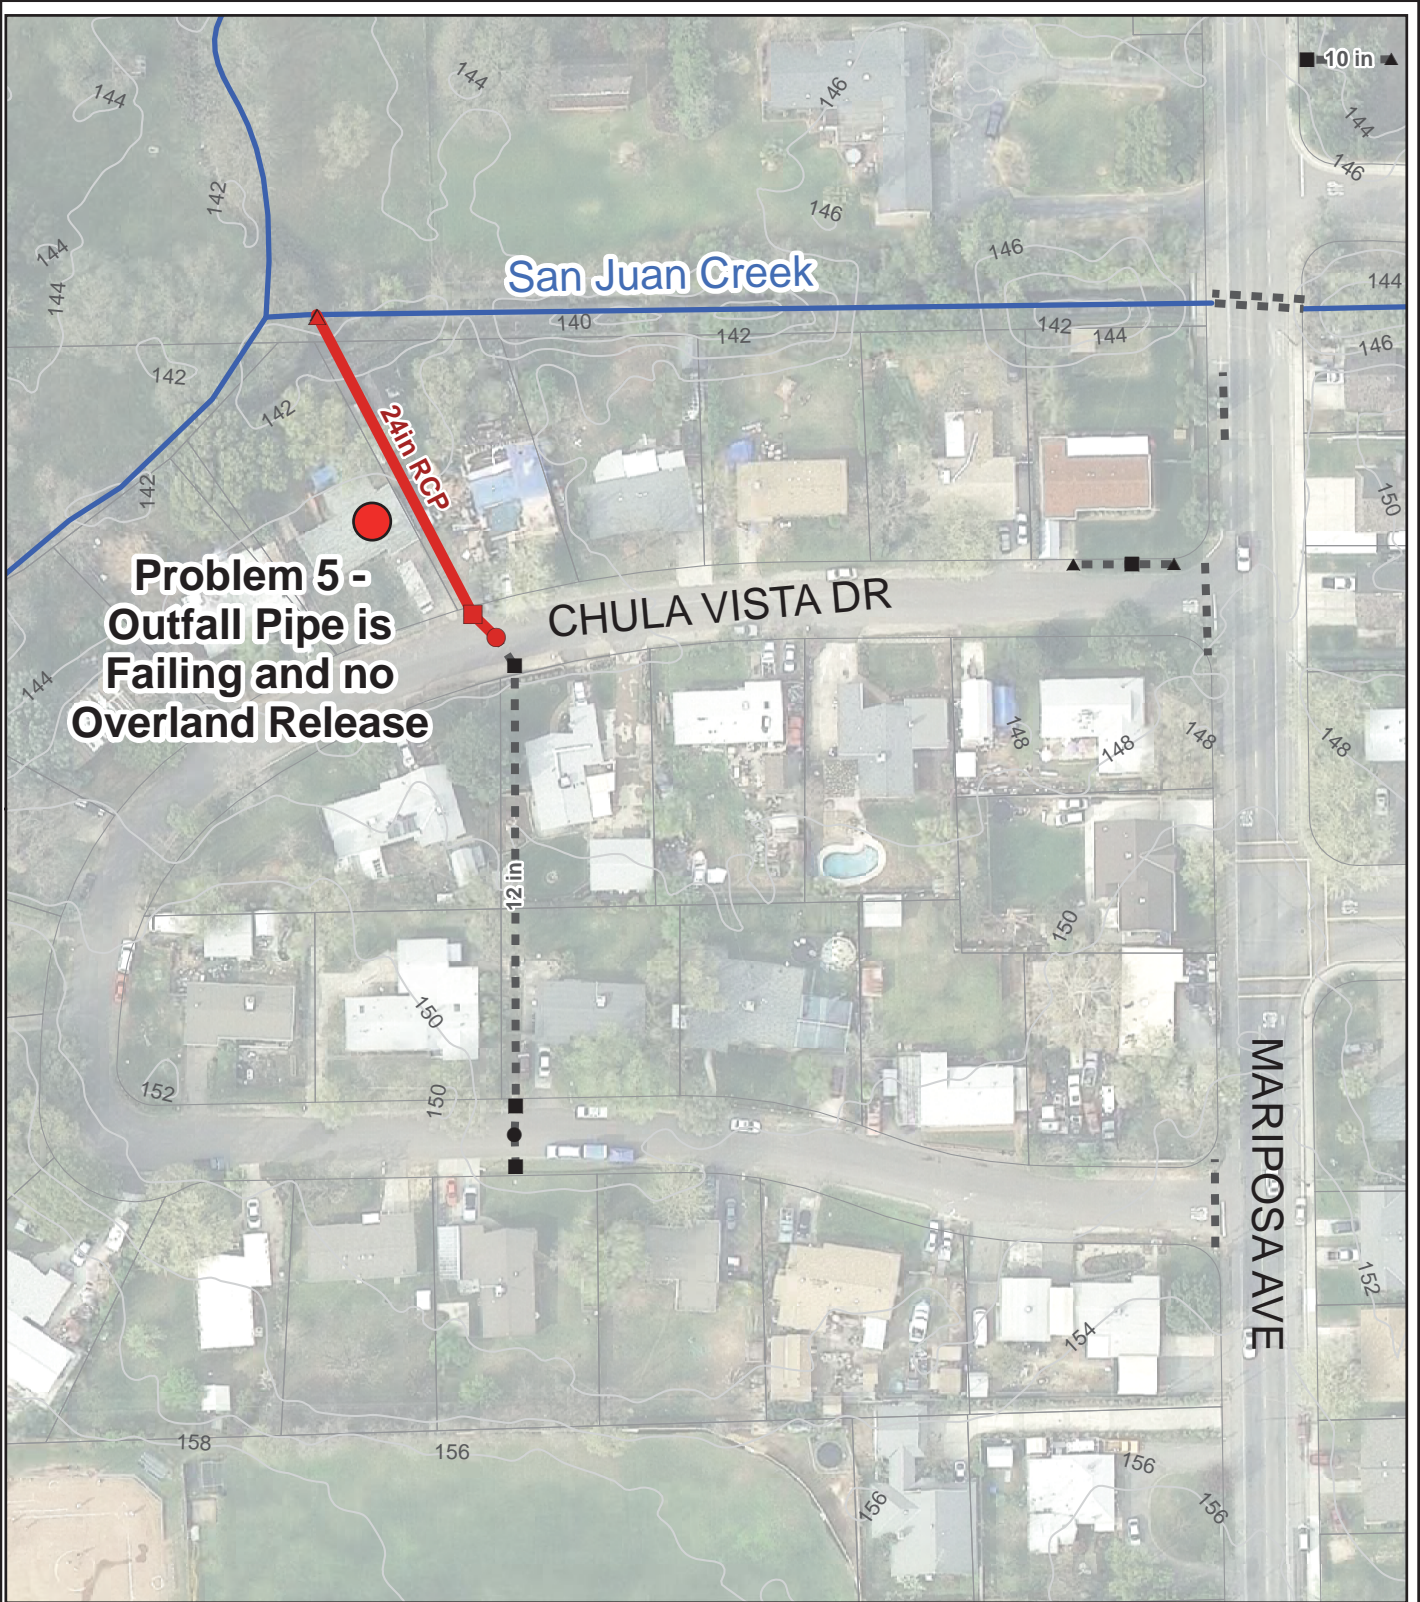
Figure 7-6
City of Citrus Heights
Neighborhoods 8, 9, and 10
Drainage Master Plan Study
Problem Location 5
and Proposed Solution

**Problem 5 -
Outfall Pipe is
Failing and no
Overland Release**

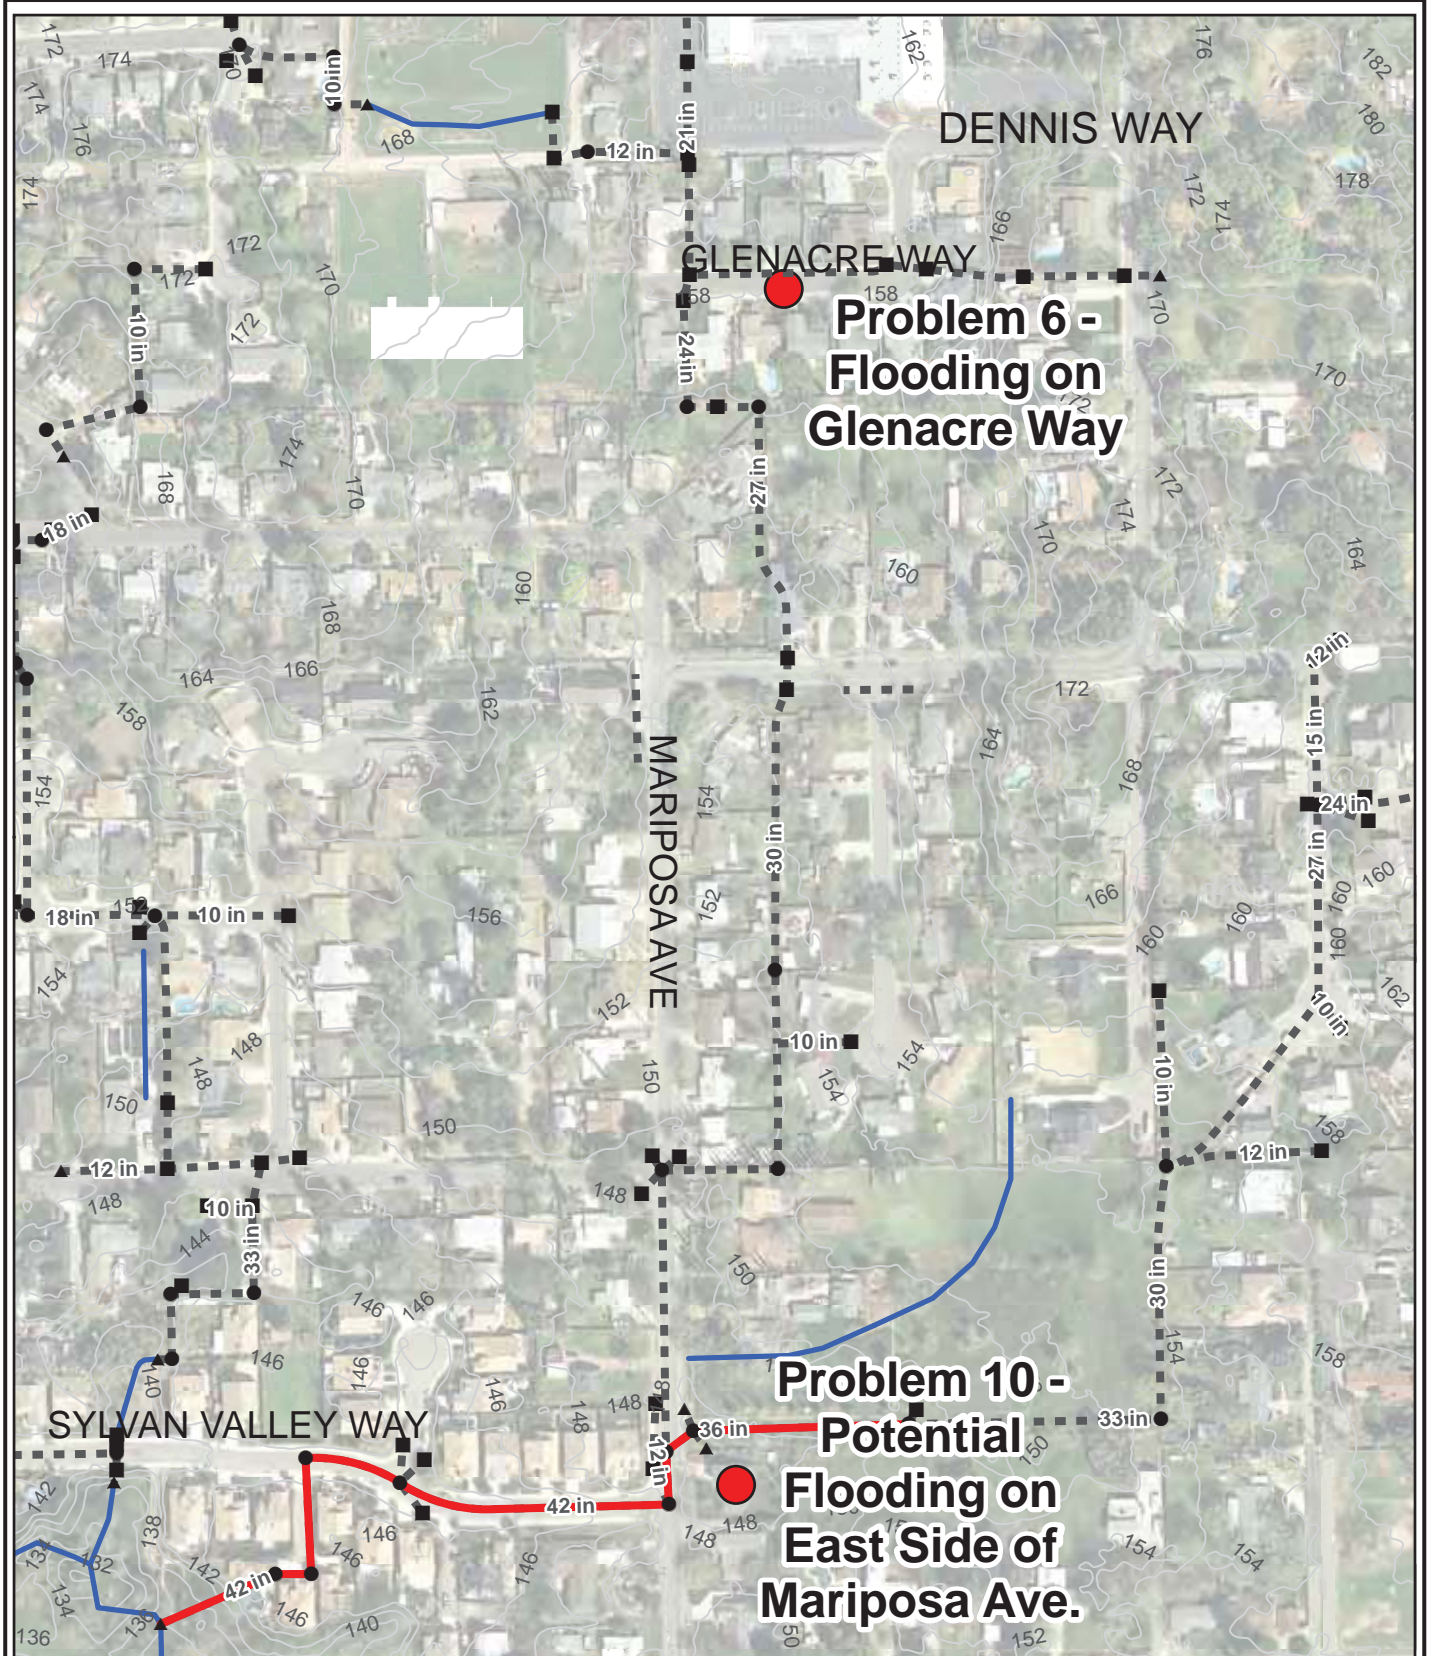
Figure 7-7
City of Citrus Heights
Neighborhoods 8, 9, and 10
Drainage Master Plan Study
Problem Locations 6 and 10

**Problem 6 -
Flooding on
Glenacre Way**

**Problem 10 -
Potential
Flooding on
East Side of
Mariposa Ave.**

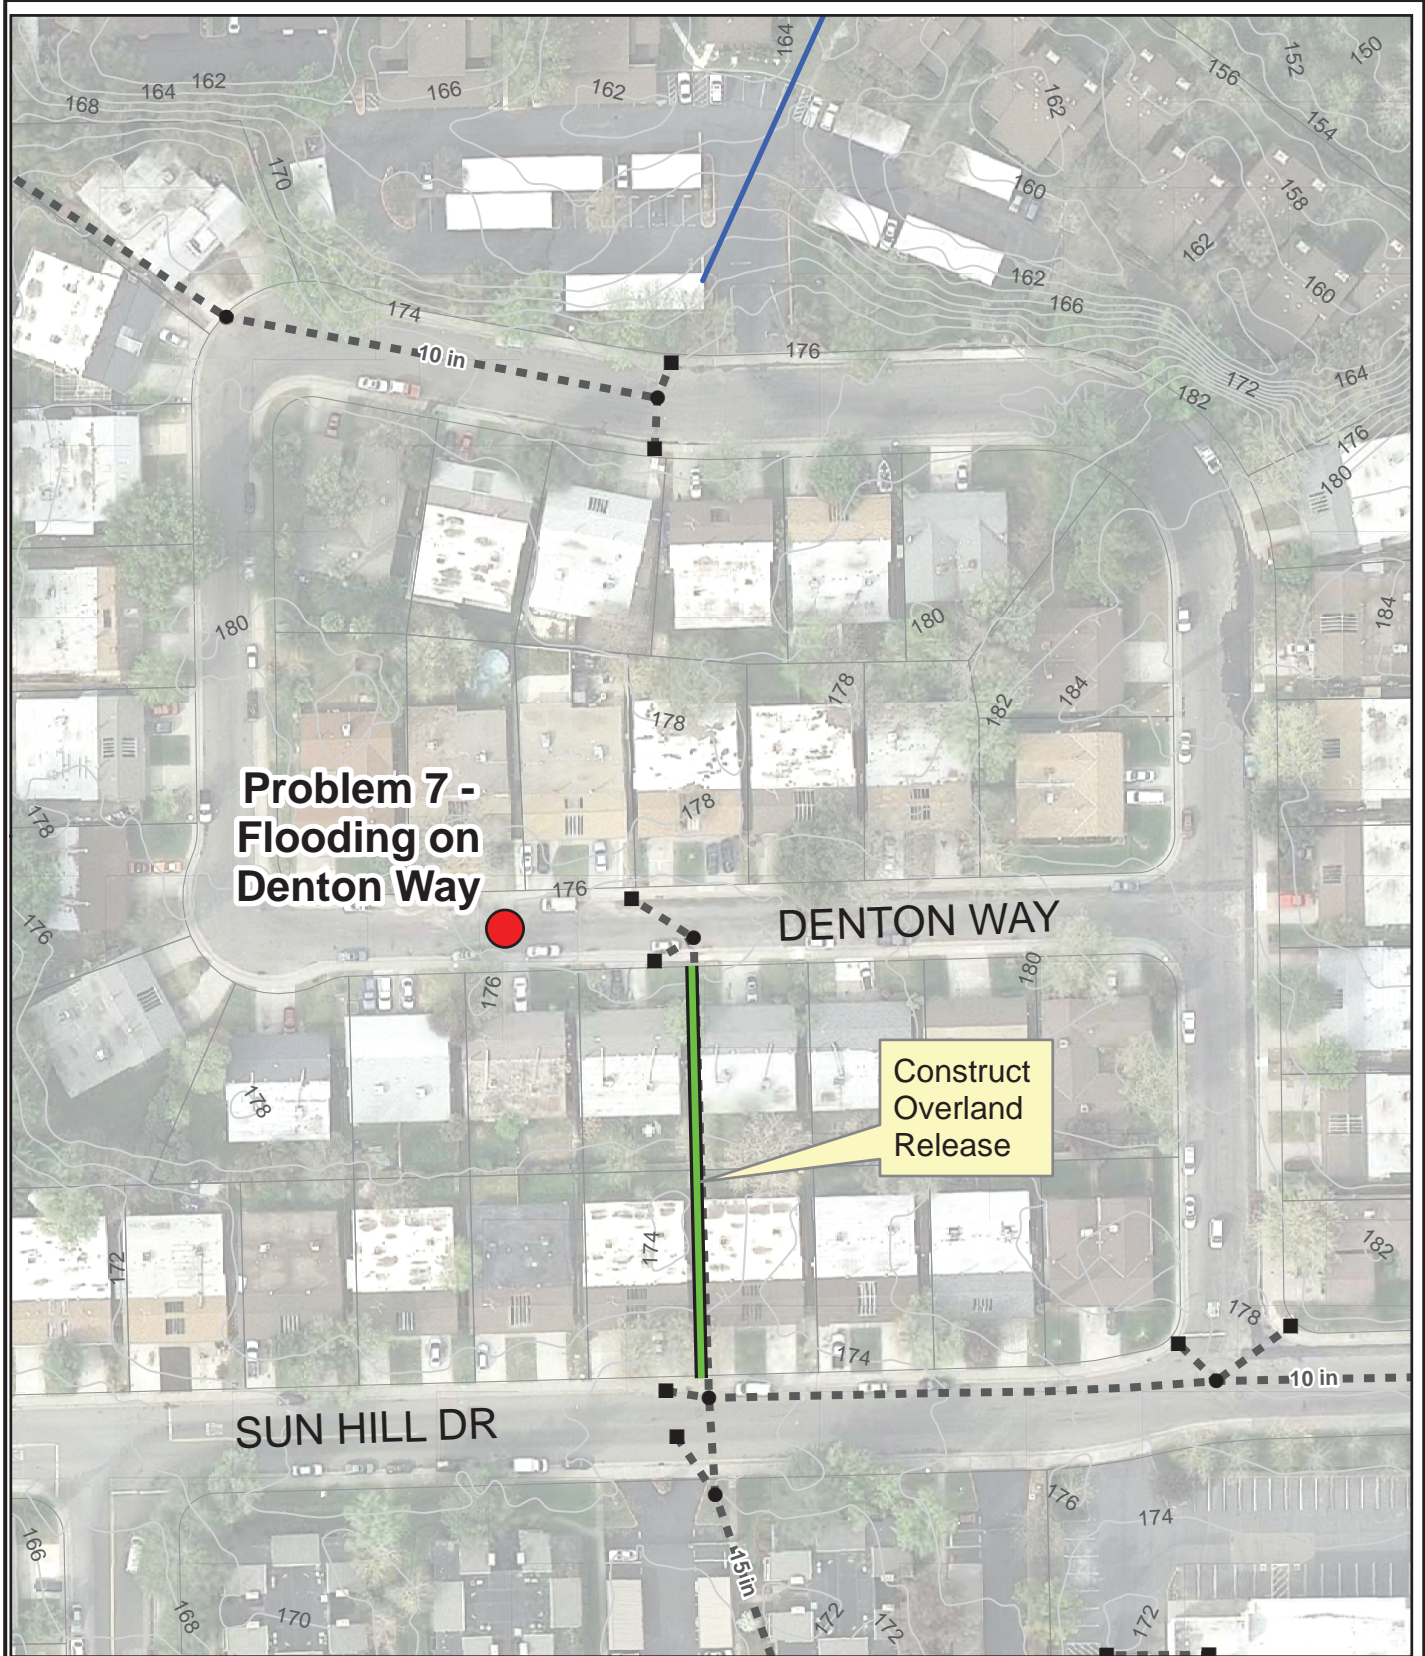
**Problem 7 -
Flooding on
Denton Way**

**Construct
Overland
Release**

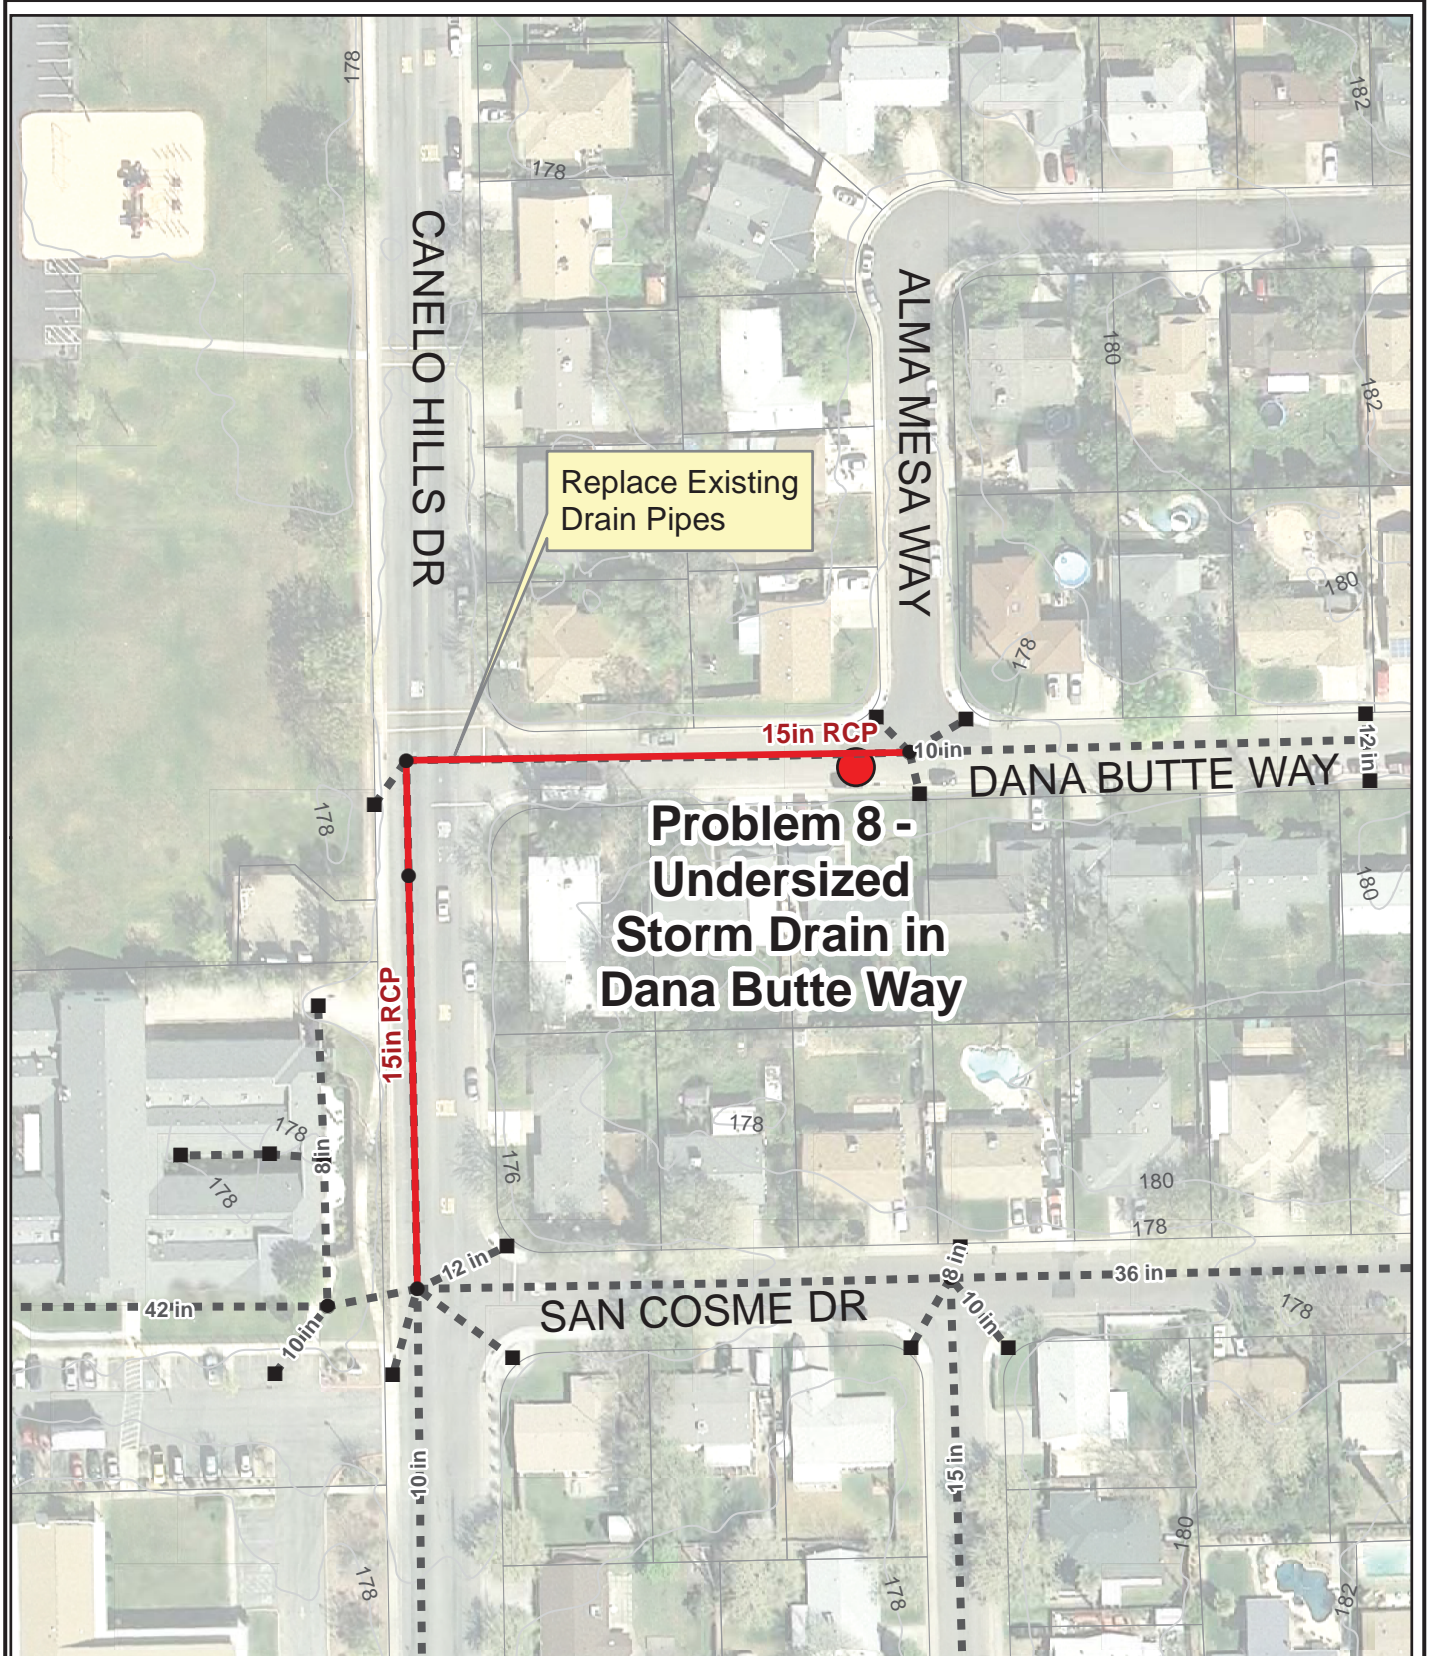
**Problem 8 -
Undersized
Storm Drain in
Dana Butte Way**
