City of Citrus Heights Neighborhoods 8, 9, and 10

Storm Drainage Master Plan Study

February 2016

396-00-12-02

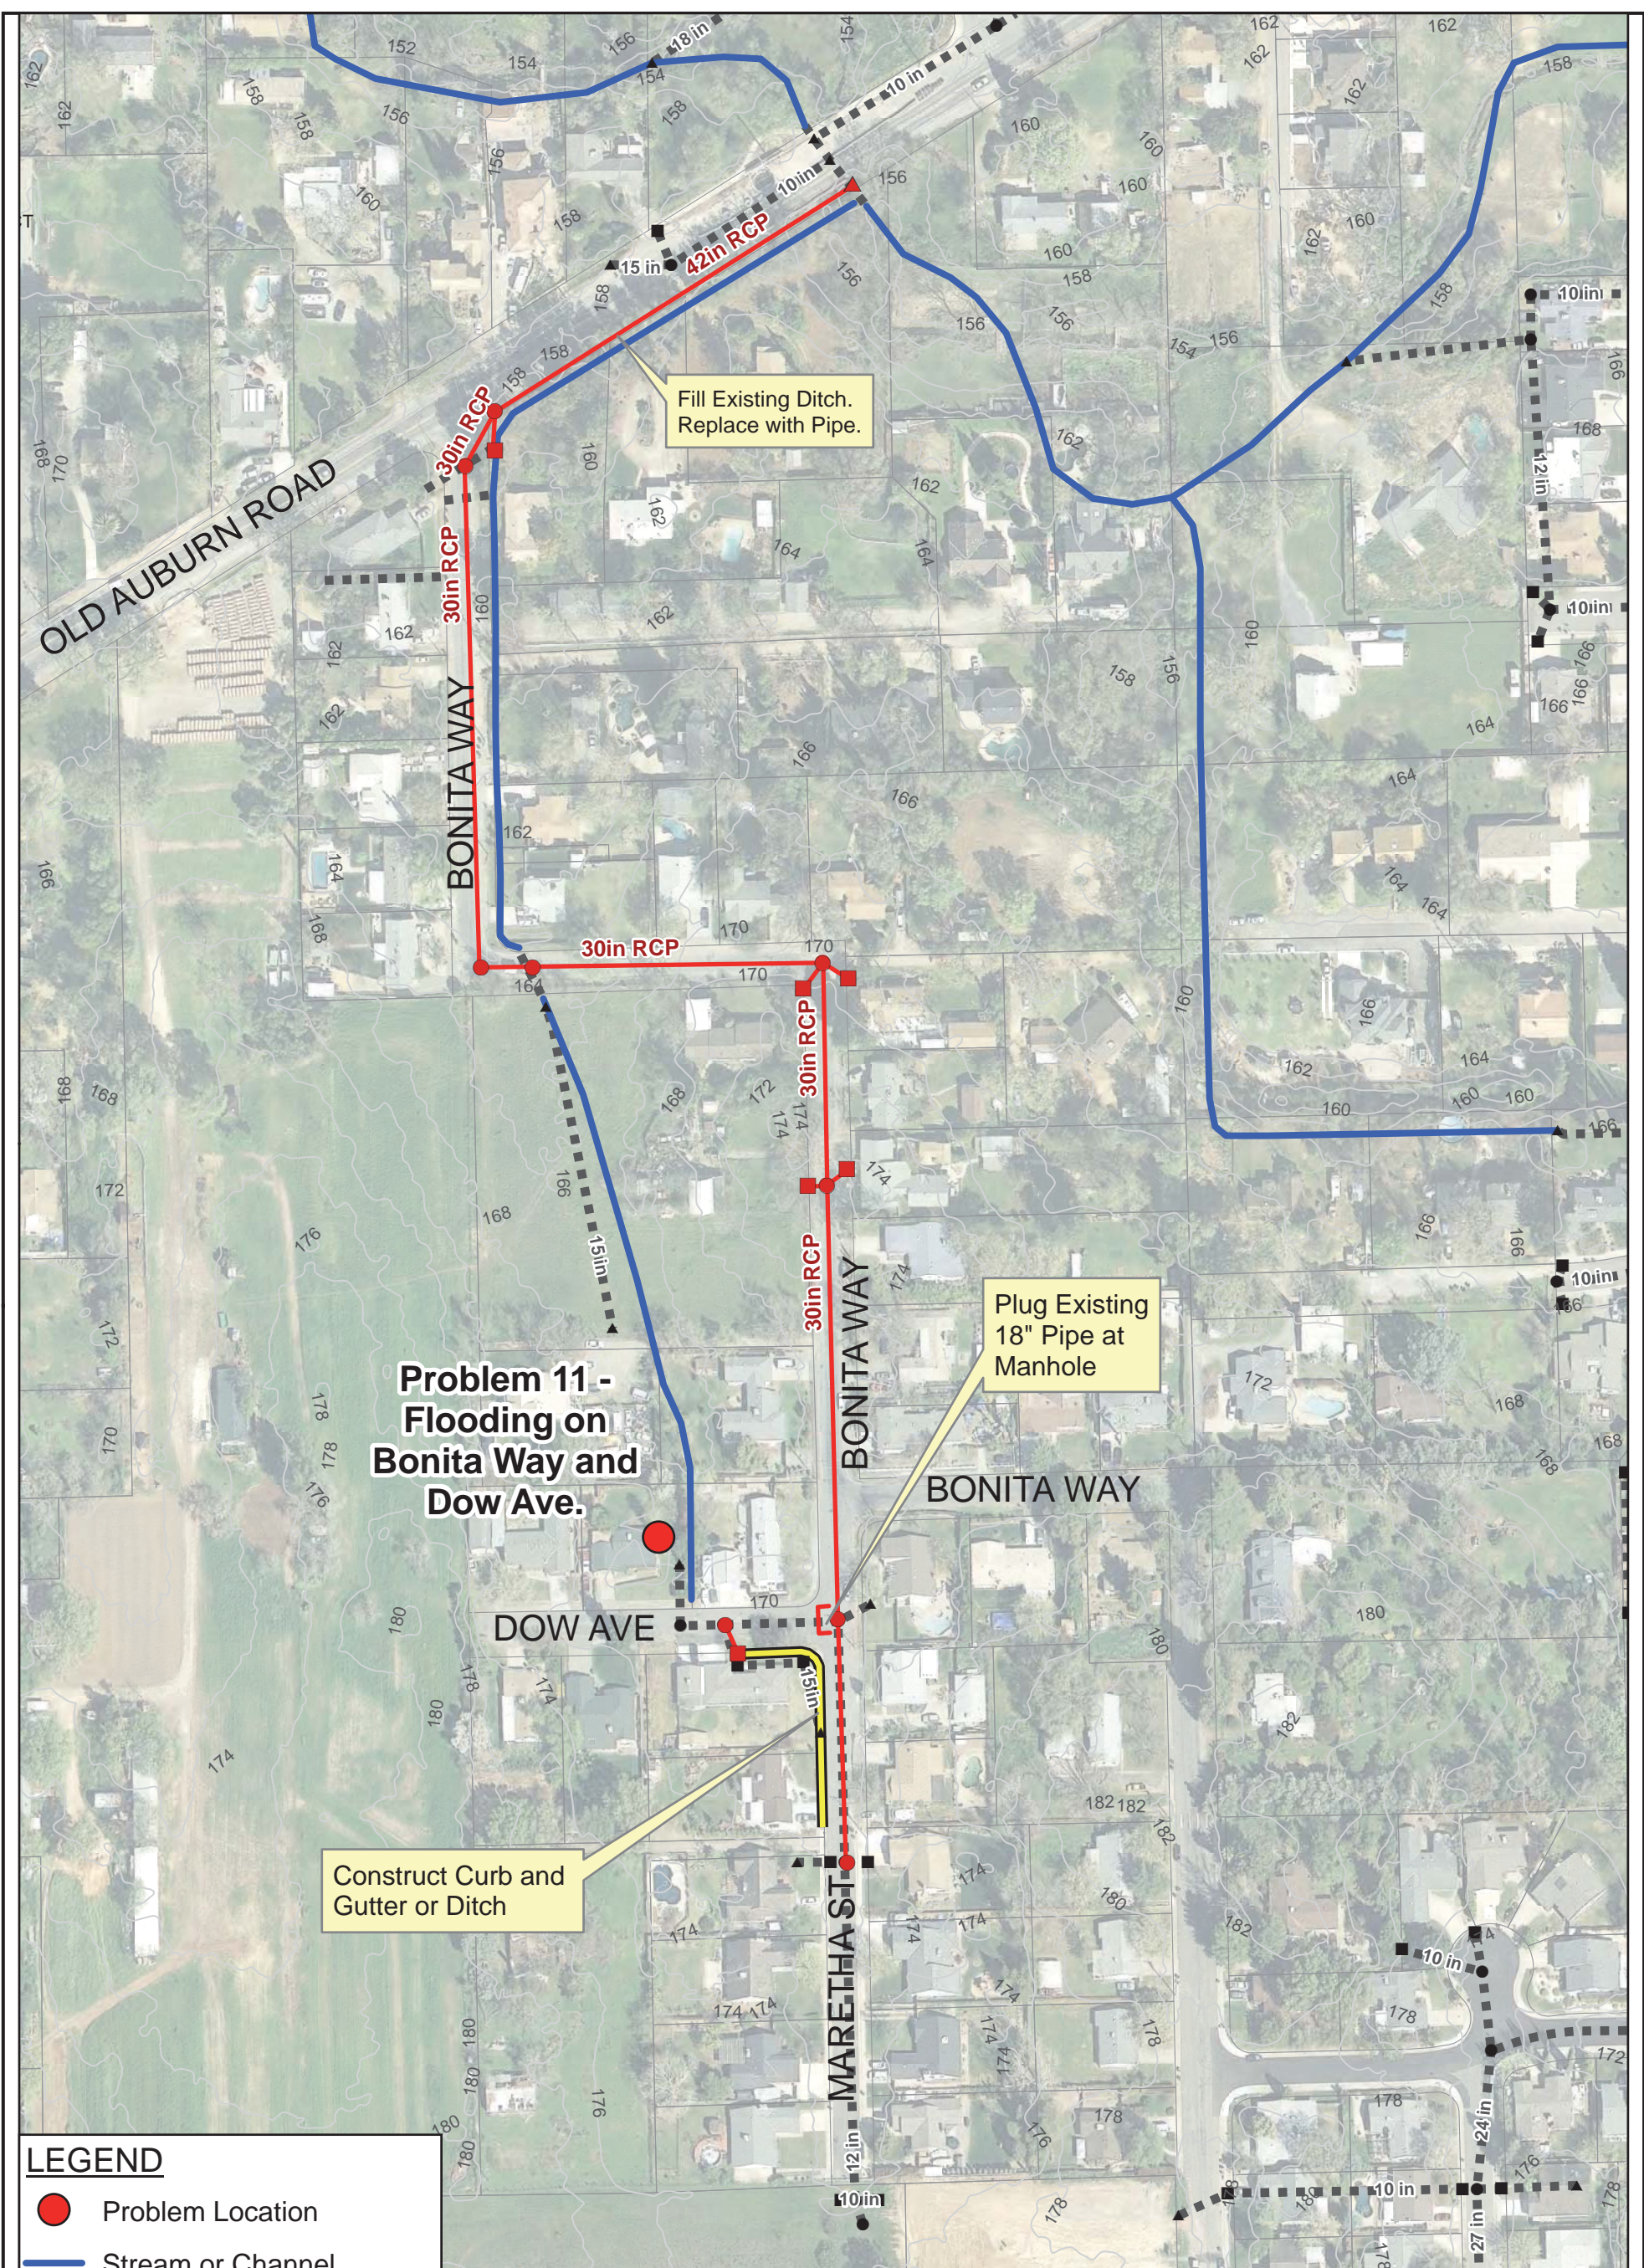
**Problem 11 -
Flooding on
Bonita Way and
Dow Ave.**

Construct Curb and
Gutter or Ditch
