CITY OF CITRUS HEIGHTS

Neighborhoods 6 & 7 Storm Drainage Master Plan Study

March 2012

396-00-10-01

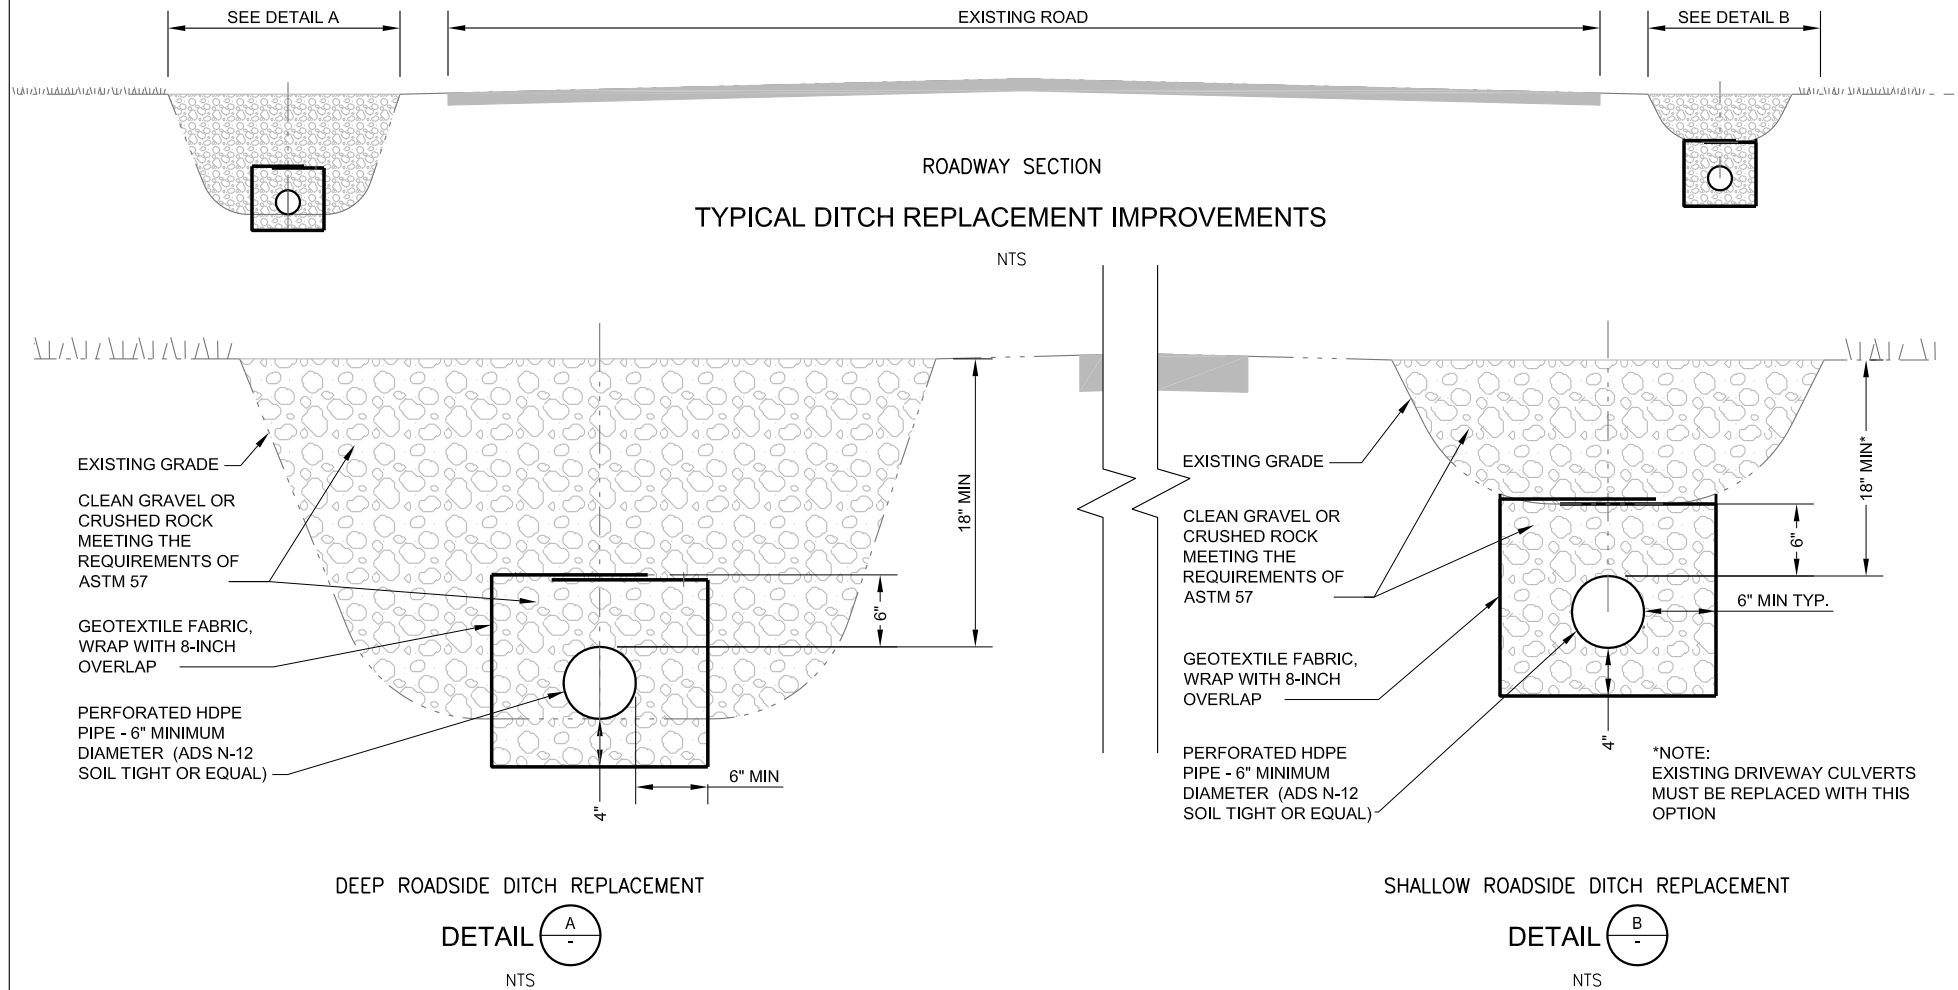
Each flooding and drainage problem location was evaluated and a recommended solution identified. In many cases, the proposed solutions affect more than one problem; therefore, multiple problems were grouped together for evaluation. The problem locations and recommended solutions are shown on Figures ES-3 through ES-14. Table ES-1 provides a summary of the problem locations and the recommended solutions. In some cases, the proposed solution involves elimination of an existing roadside ditch. Figure ES-15 shows the general approach for eliminating the roadside ditches.

City of Citrus Heights
Neighborhoods 6 and 7 Drainage Master Plan Study
Ditch Replacement Detail
