Auburn Sunrise Area
Master Drainage Study

Drainage System
Inventory Worksheet

FIGURE 6-2
City of Citrus Heights
Neighborhoods 6 and 7
Drainage Master Plan Study

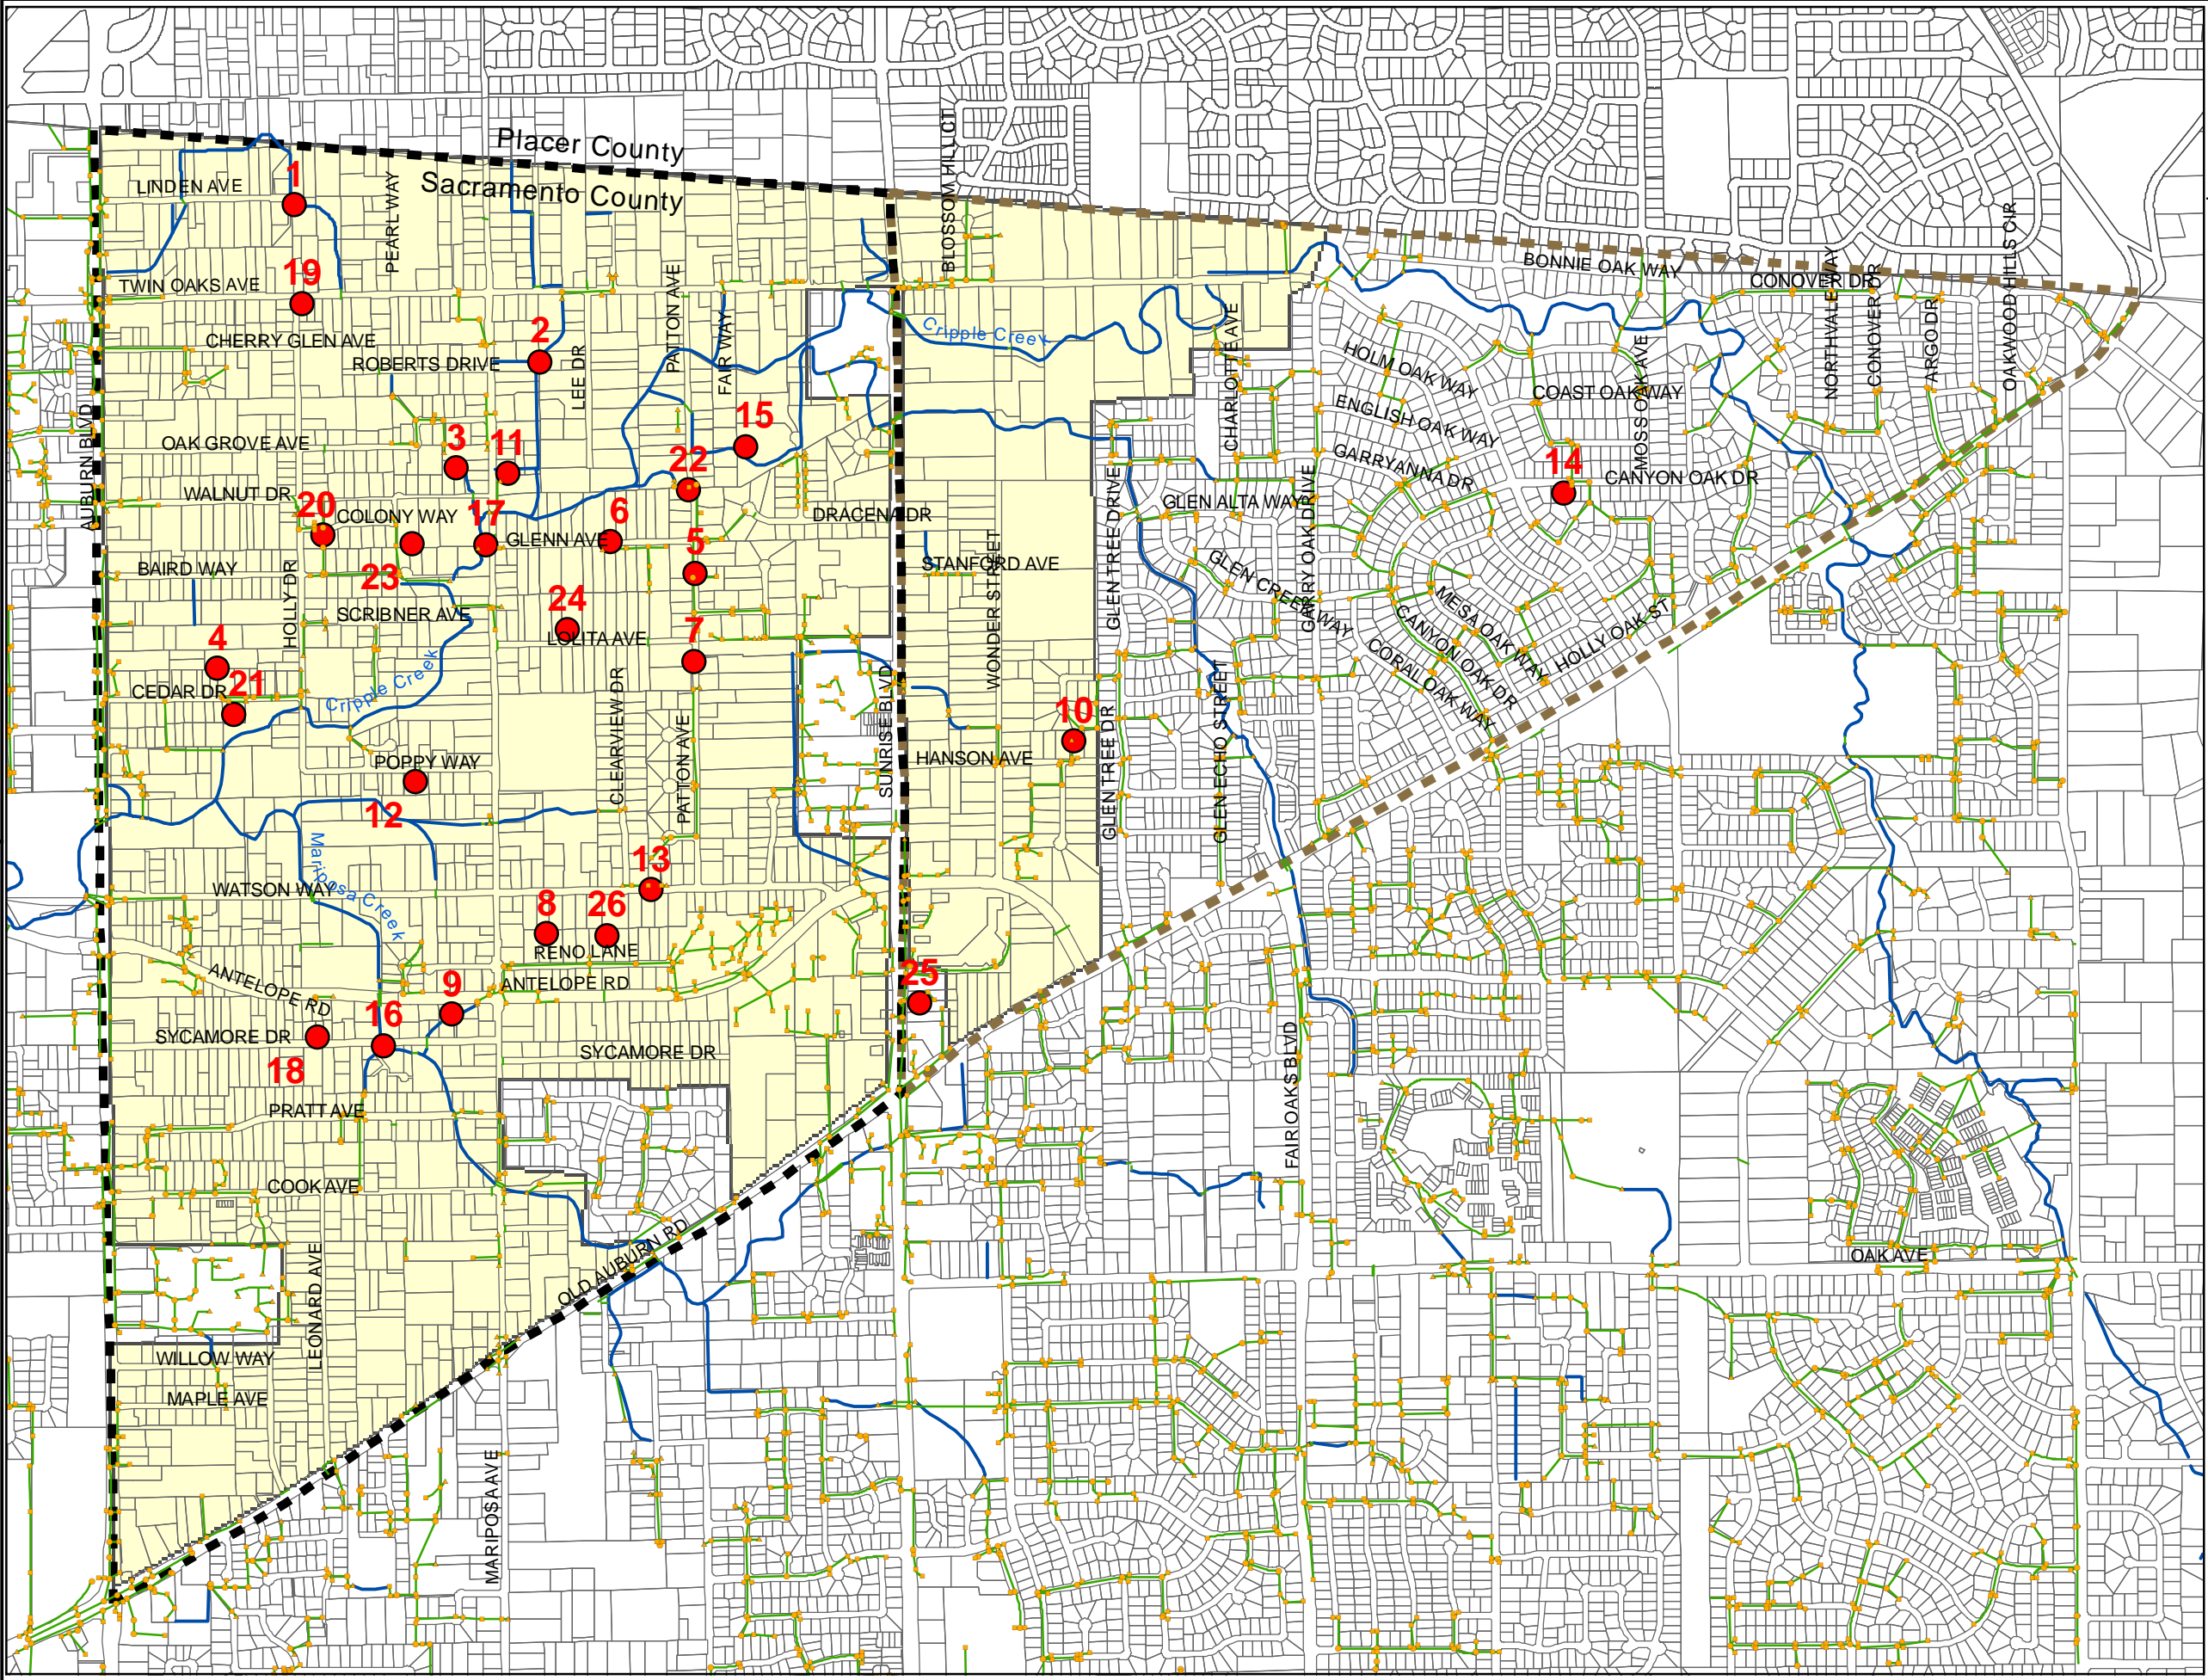
- LEGEND**
- Existing Inlet
 - Existing Outfall
 - Existing Manhole
 - Problem Location
 - Existing Drainage Pipe
 - Stream or Channel
 - Neighborhood 6
 - Neighborhood 7
 - Detailed Study Area

Based on the above activities, a total of 26 flooding and drainage problems were identified for evaluation. The general locations of the problems are shown on Figure 7-1. Relatively complex problems were assessed using hydrologic and hydraulic modeling. Less complex problems were evaluated with spreadsheet calculations or normal depth analyses. For the simplest problems with relatively straightforward solutions, City staff directed that only qualitative analyses be performed. For those problems, general solutions were recommended without engineering calculations being performed.
