Old Auburn/Fair Oaks Intersection: Collision Statistics

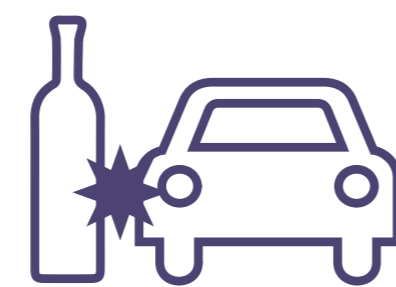
Many of the collisions that occurred at Old Auburn Road/Fair Oaks Boulevard involved vehicles that were making the northbound left-turn from Fair Oaks Boulevard onto Old Auburn Road.

16 collisions involved vehicles making the north-bound left-turn and colliding with the planter barriers

15 of 16 involved only one vehicle

11 of 16 occurred during rainy/wet conditions

5 of 16 occurred during nighttime/dark conditions

5 of 16 occurred due to driver impairment

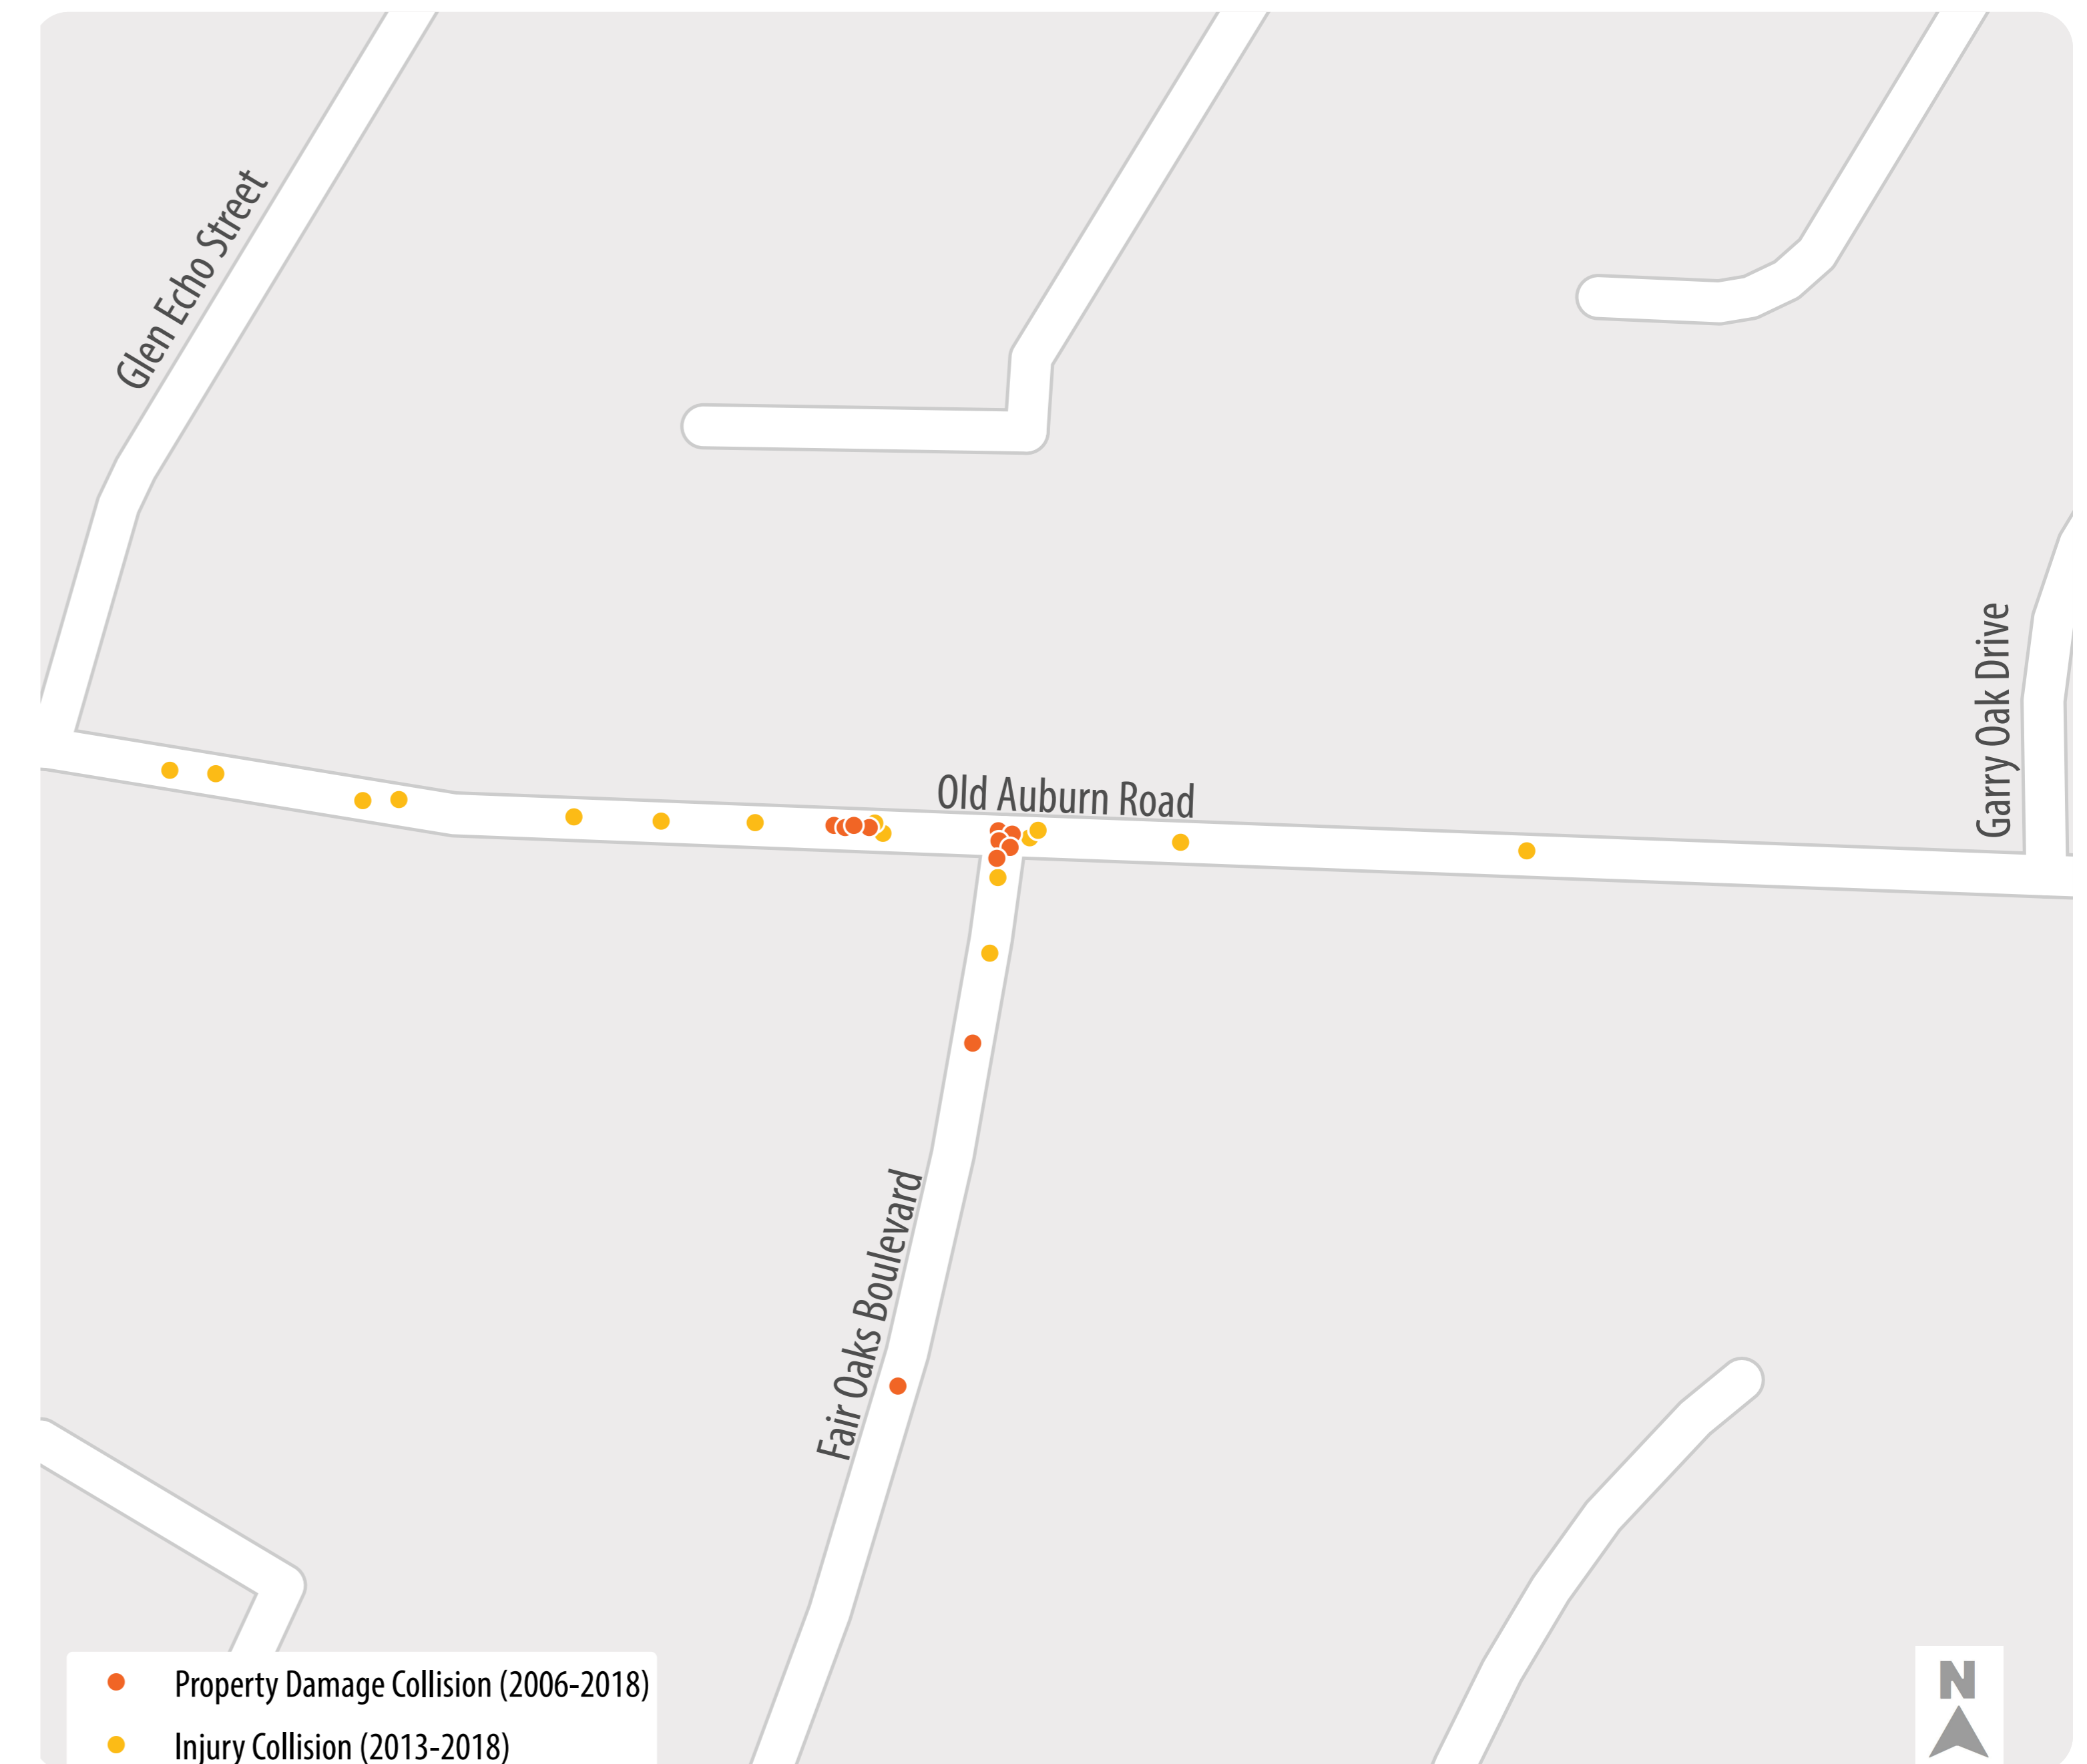
Old Auburn/Fair Oaks Collisions

This map shows injury collisions (source: SWITRS, 2006-2018) and property damage collisions (source: TIMS, 2013-2018).
